PORT ANGELES FIRE HOUSE

Condition Assessment

July 2011

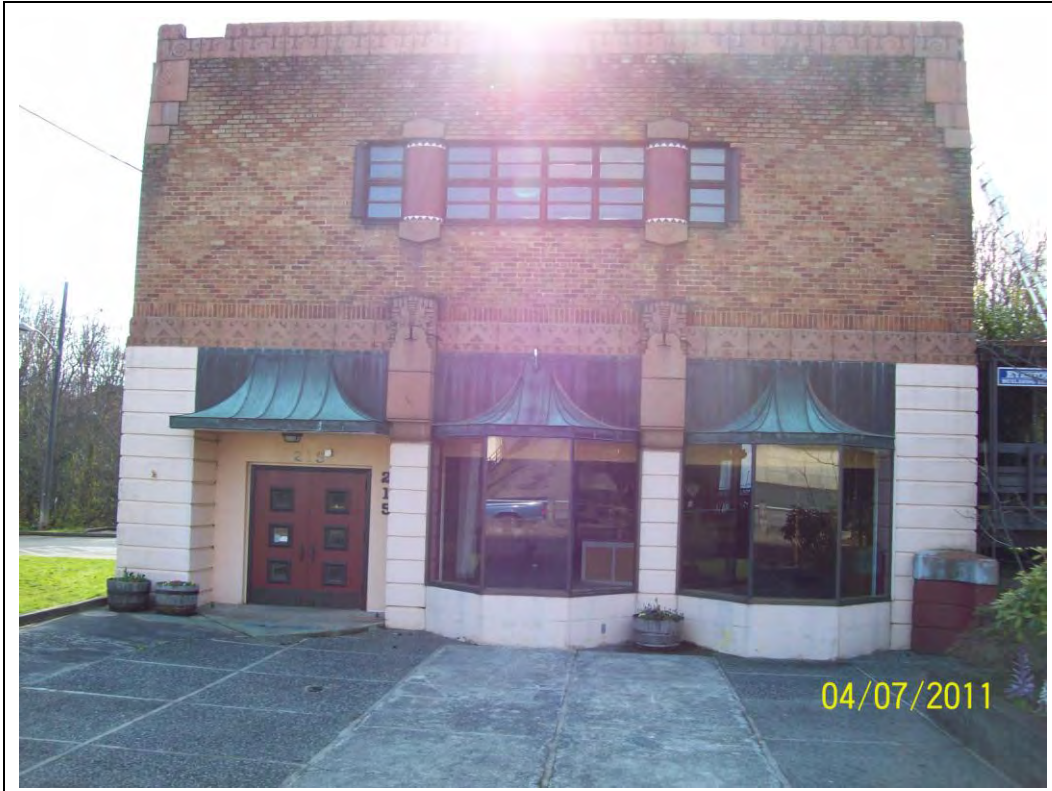
1. Main entrance to former firehouse. Several exterior paints were sampled to be tested as suspect LBPs.

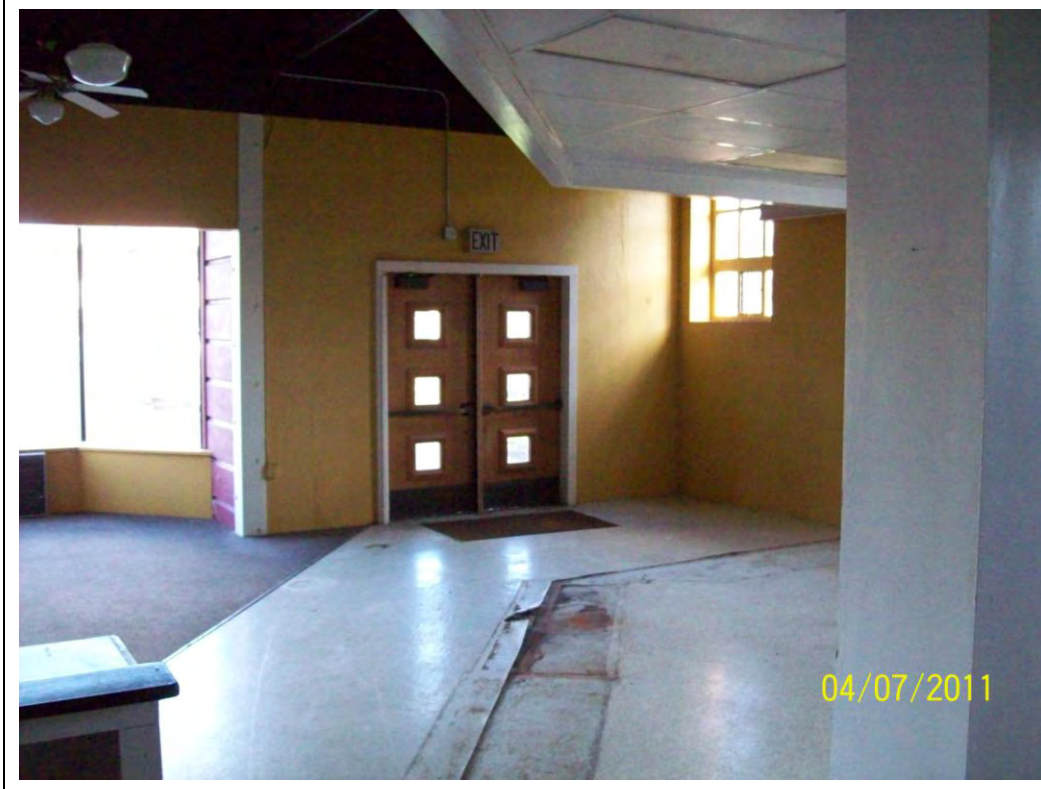
2. View from main floor interior toward front entrance to building. Visible carpet, vinyl, floor tiles, drop down ceilings, and paints were sampled.

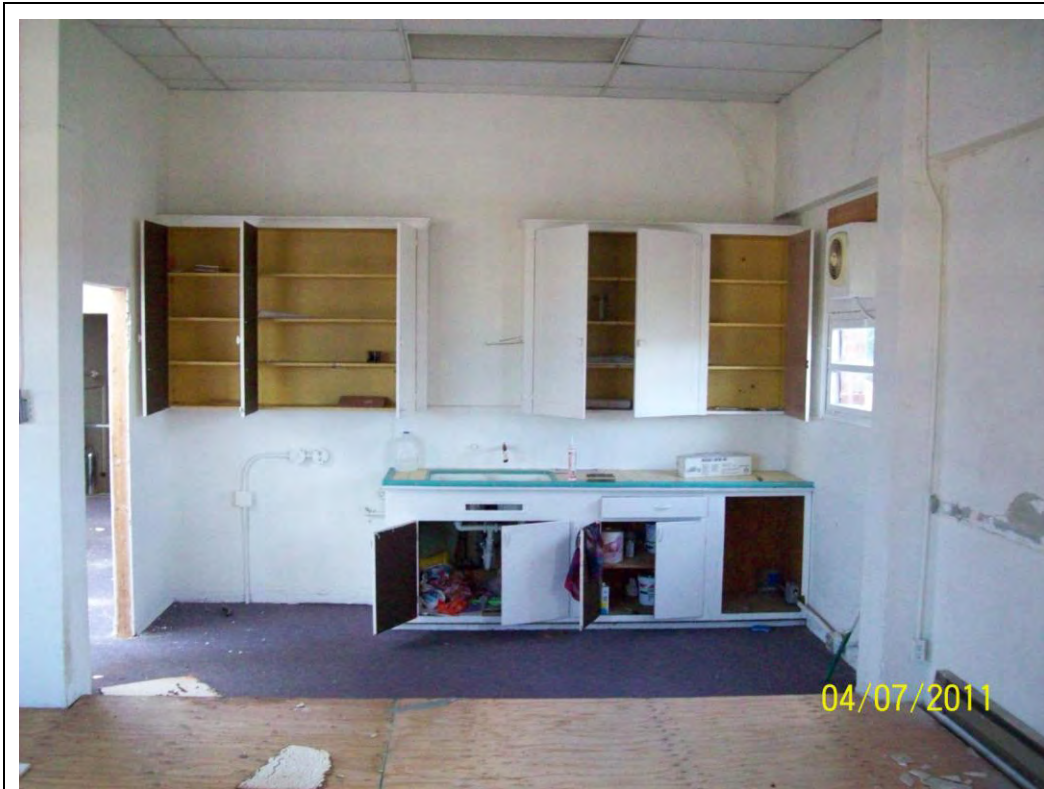
3. Upper floors also had floor tiles, vinyl, painted concrete, and LBPs. Samples of wallboard and tape, and plaster wall and ceiling coverings were collected.

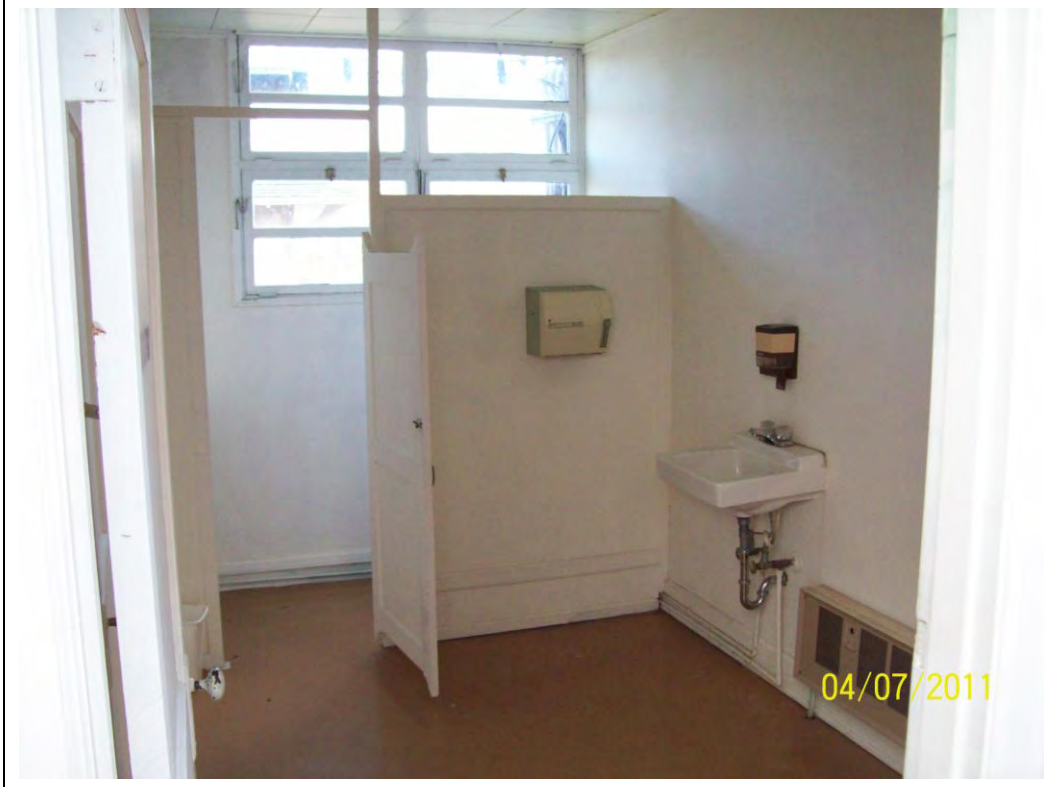
4. Bathrooms on the upper floors and throughout the building had a variety of floor coverings that were sampled.

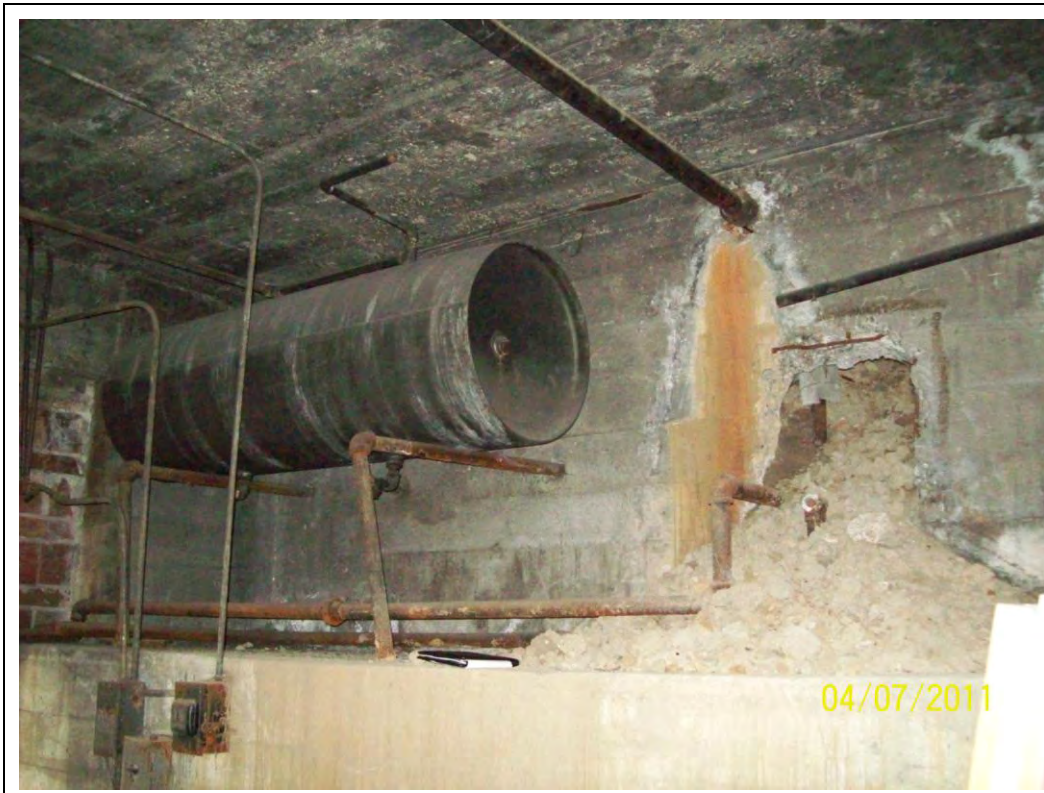
5. Tanks and piping in the basement may have been part of the former heating system. No LBP samples were collected in the basement, as no significant painted surfaces were observed.

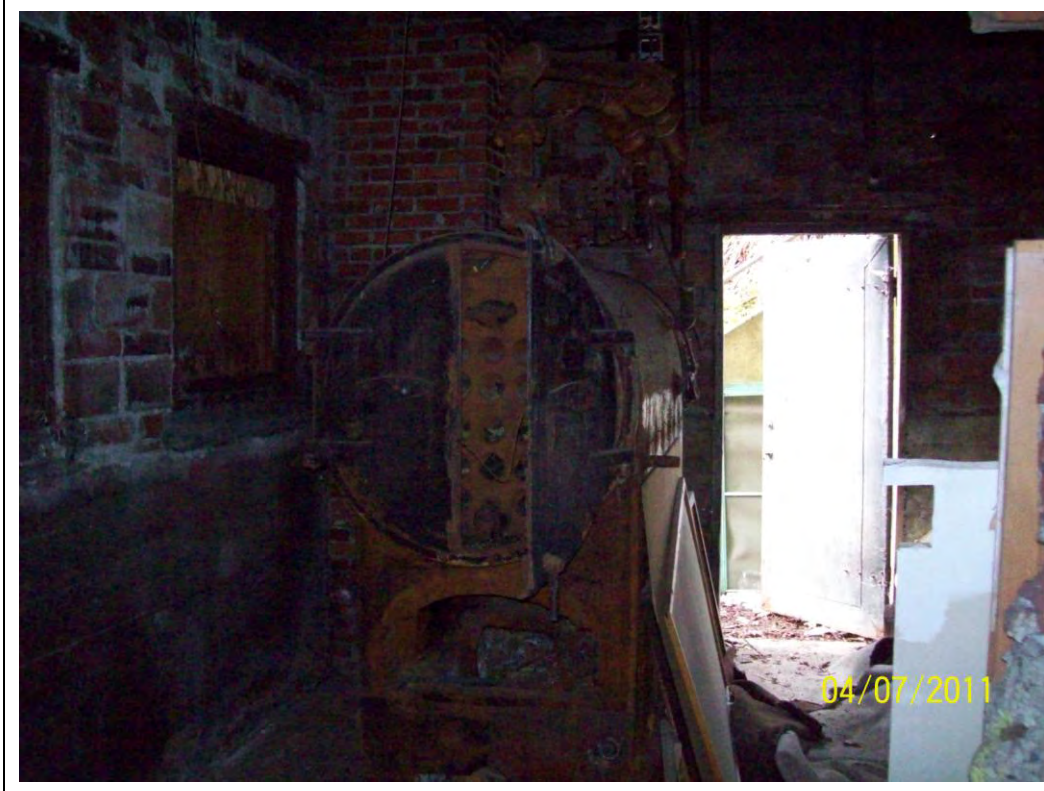
6. The relict boiler was located in the basement.

Basement suspect AMC samples included mortar from bricks and window putty.

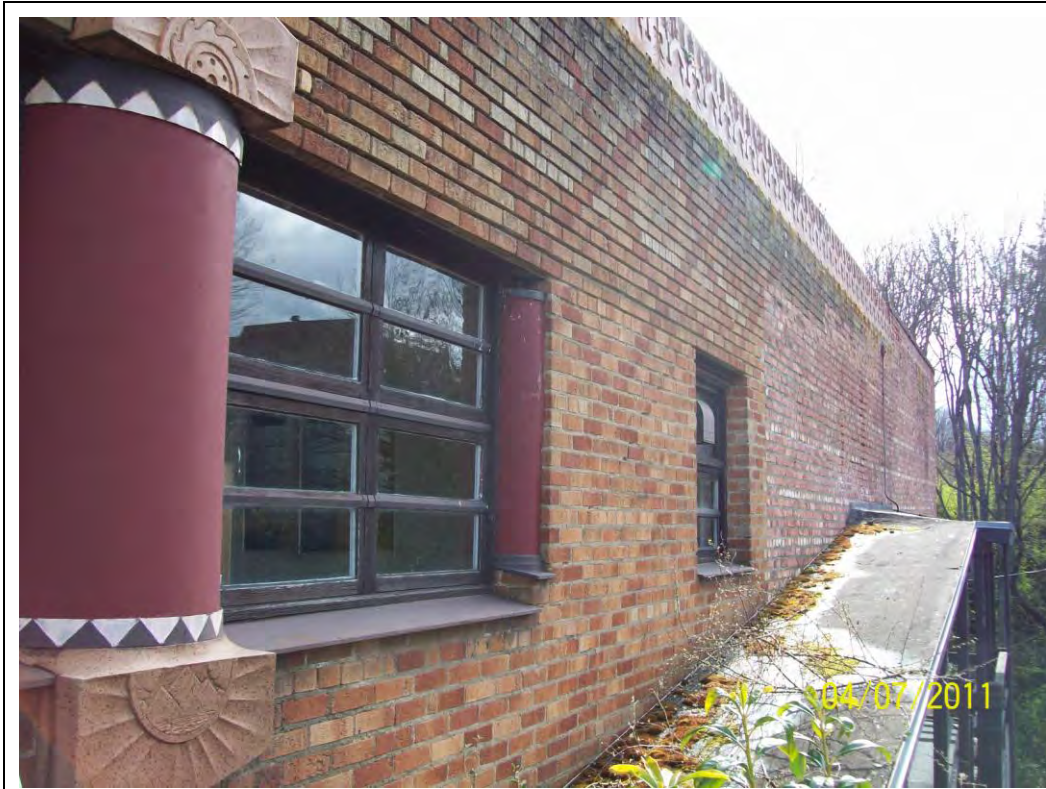
7. Exterior samples included mortar, window putty, roofing materials, and mastics.

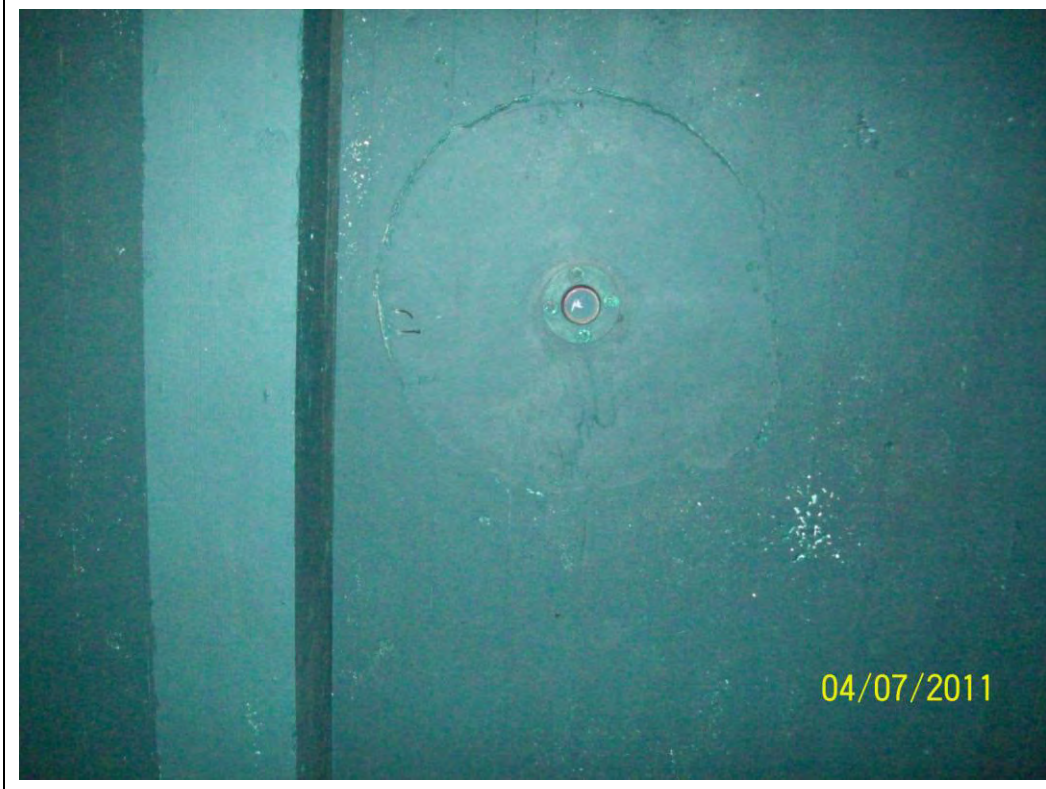
8. Some plaster coatings and wall materials were found throughout the building. There were other unusual building compounds such as *Pyroblock* and some fibrous "hollow" ceramics.

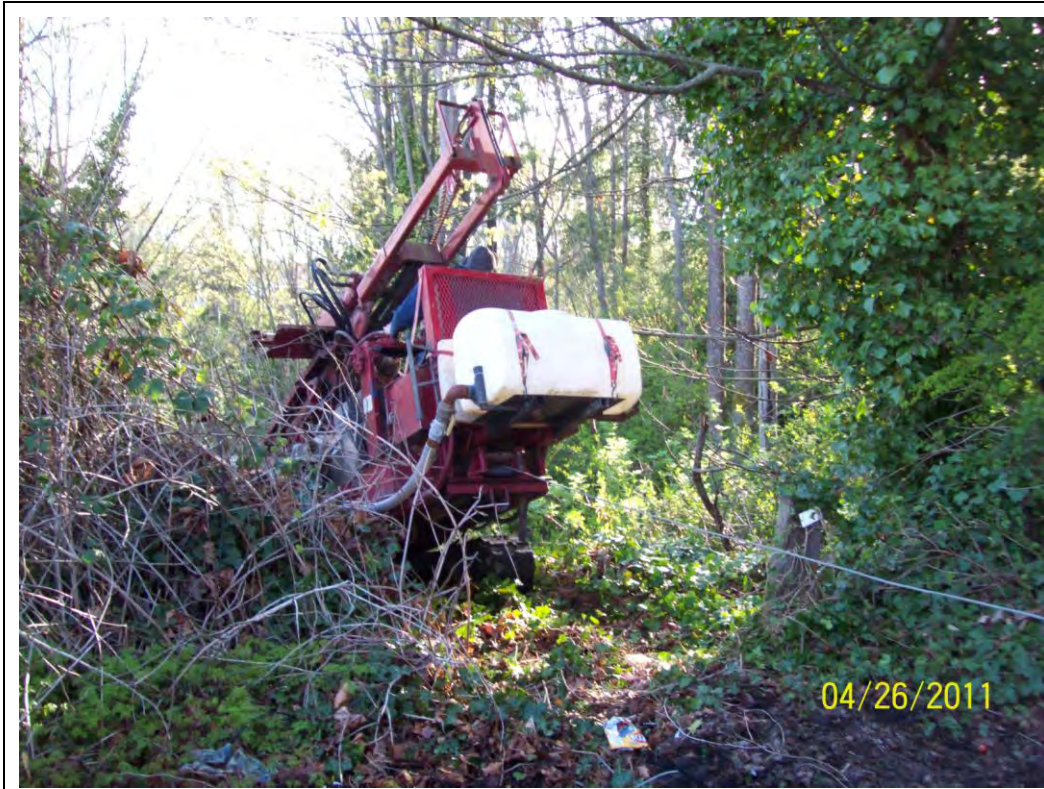
1. An attempt to drill with a track rig on the slope to the south of the building was aborted. A winch to the large drill rig was connected, but the slope was too slippery to negotiate.

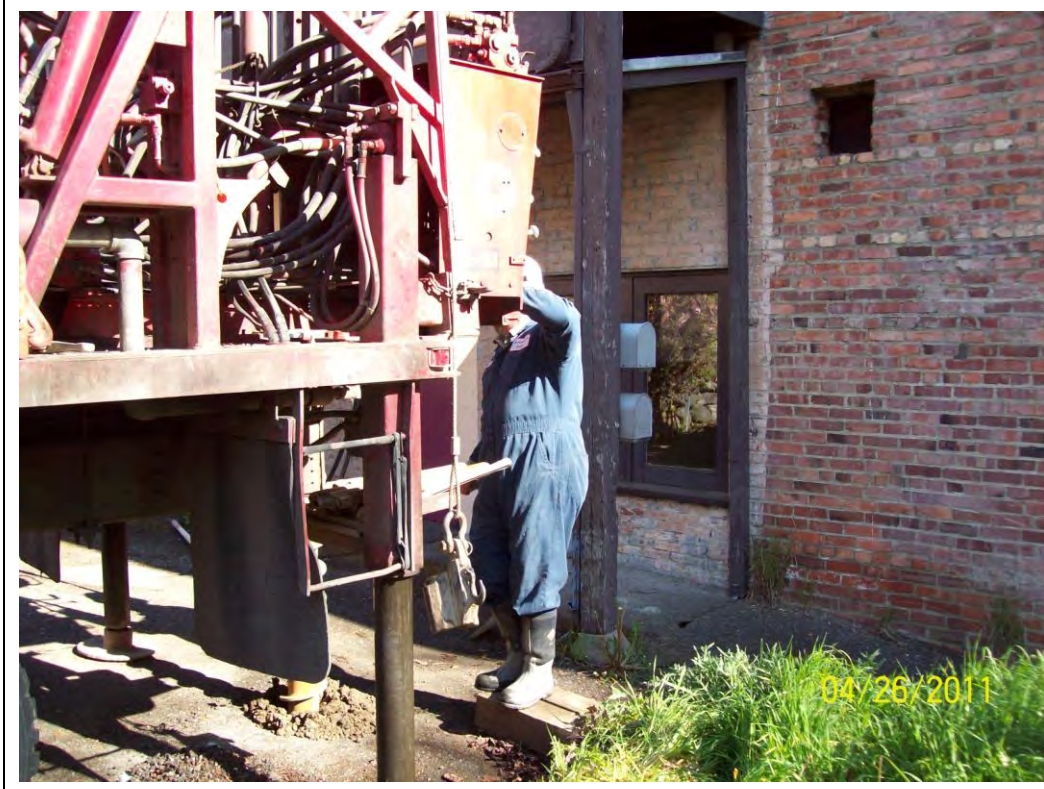
2. Following the attempt at the slope, the truck-mounted rig was set up on the west side of the building for borehole B1. The hole was scheduled for 40 feet, but was advanced to 50 feet below ground surface (bgs).

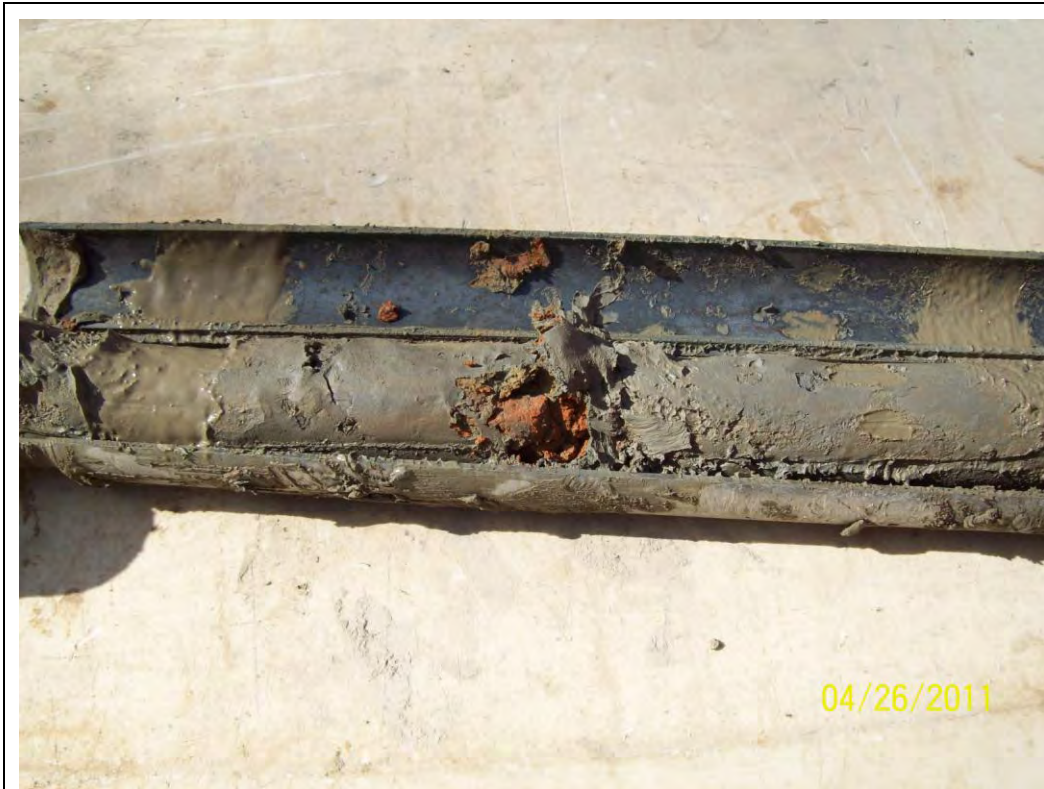
3. Initial soils encountered were soft clays and fine silts with moisture varying from damp to moist. The relict brick suggested the sediments were historically emplaced by human or fluvial/alluvial processes.

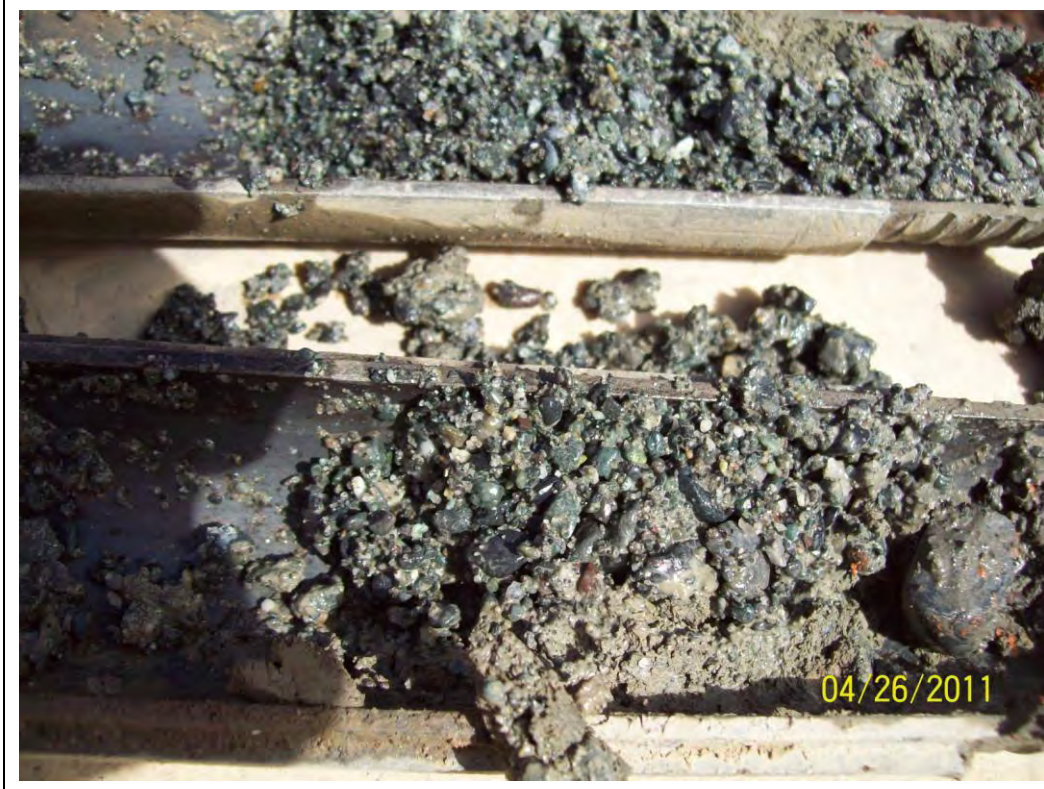
4. Groundwater was encountered at about 33.5 feet bgs in B1.

Hydrocarbon odors suggesting contamination was also encountered at about 35 feet. The silty sand and sand with heavy gravel and cobbles shown here became more dense and sandier downhole.

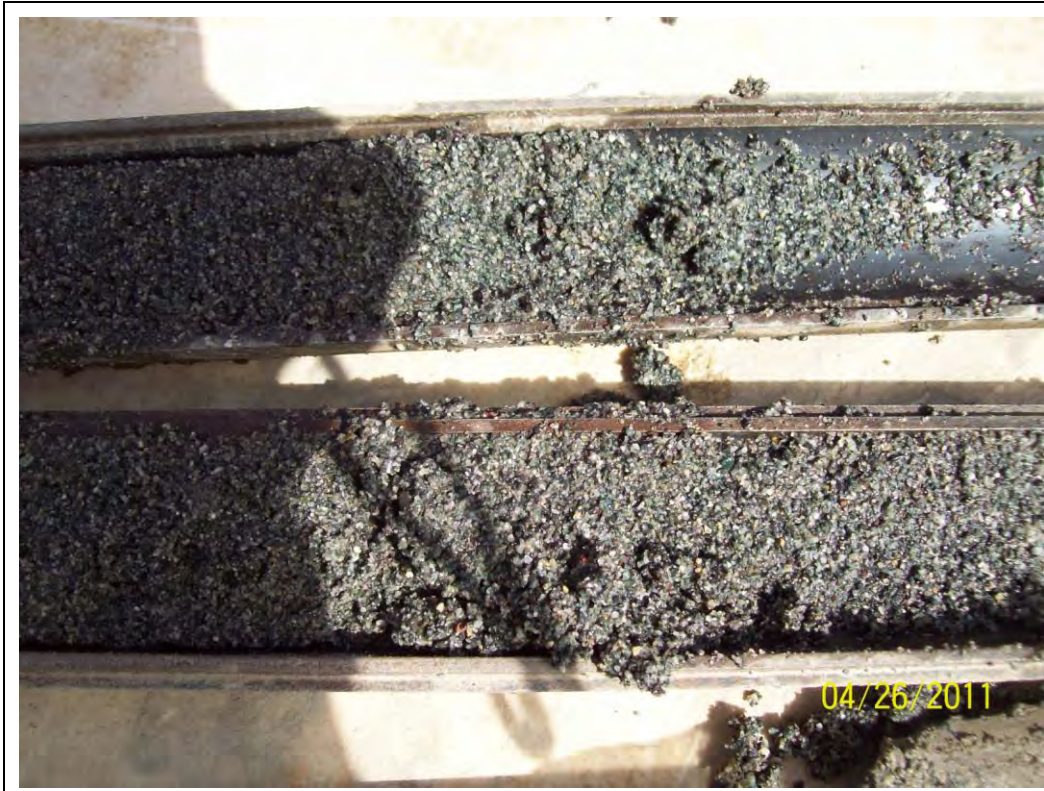
5. Some lenses of moist to saturated, dense, well sorted, poorly graded fine sands were encountered. See borehole logs for details.

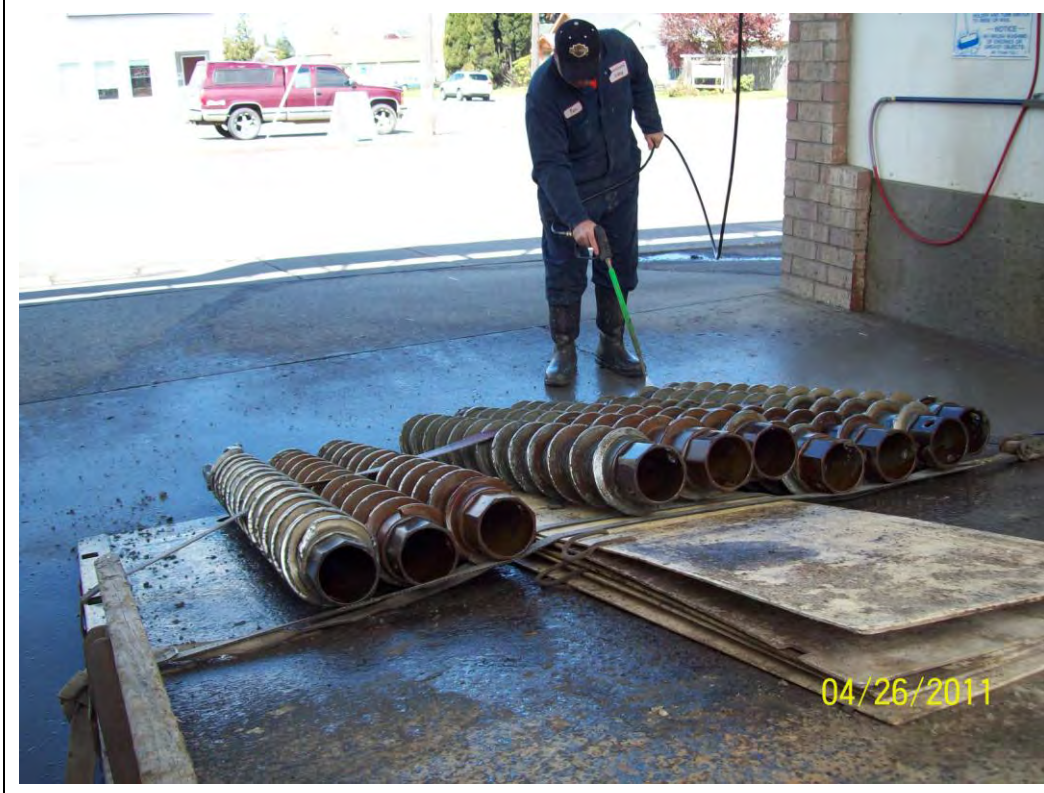
6. After encountering contamination in B1, sheen on rods and augers had to be removed. Decontamination of equipment was undertaken prior to initiation of another borehole.

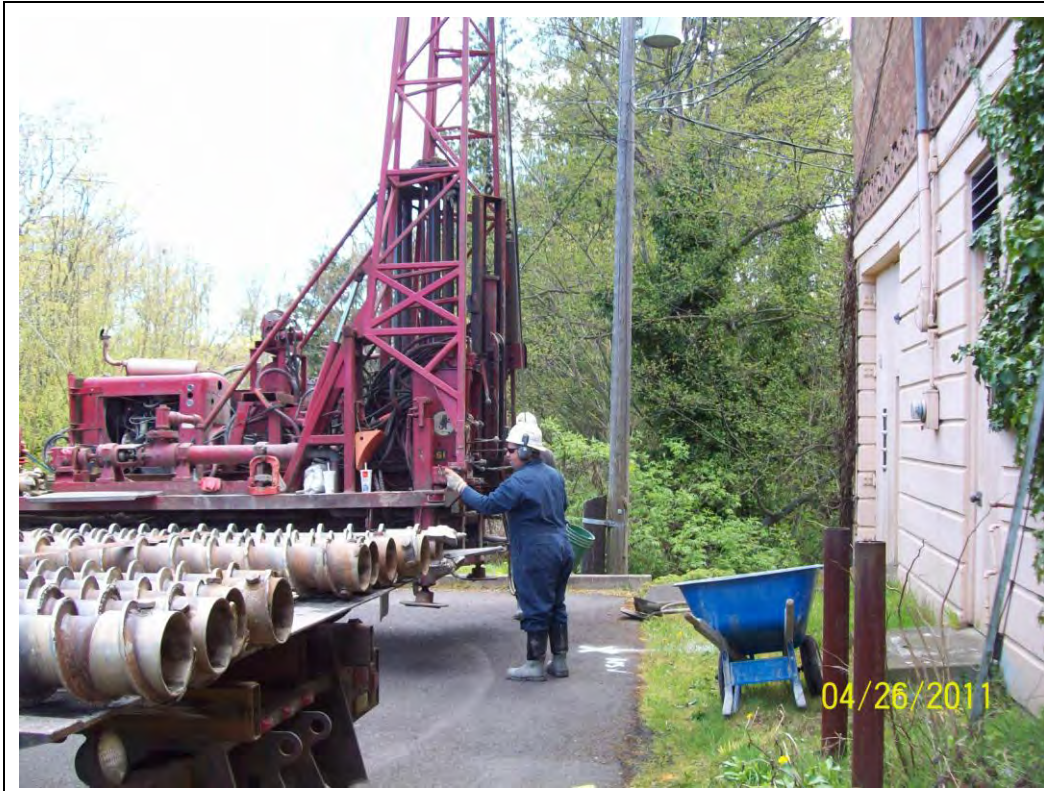
7. Borehole B2, also advanced to 50 feet bgs, was on the east side of the building, adjacent to visible building settlement.

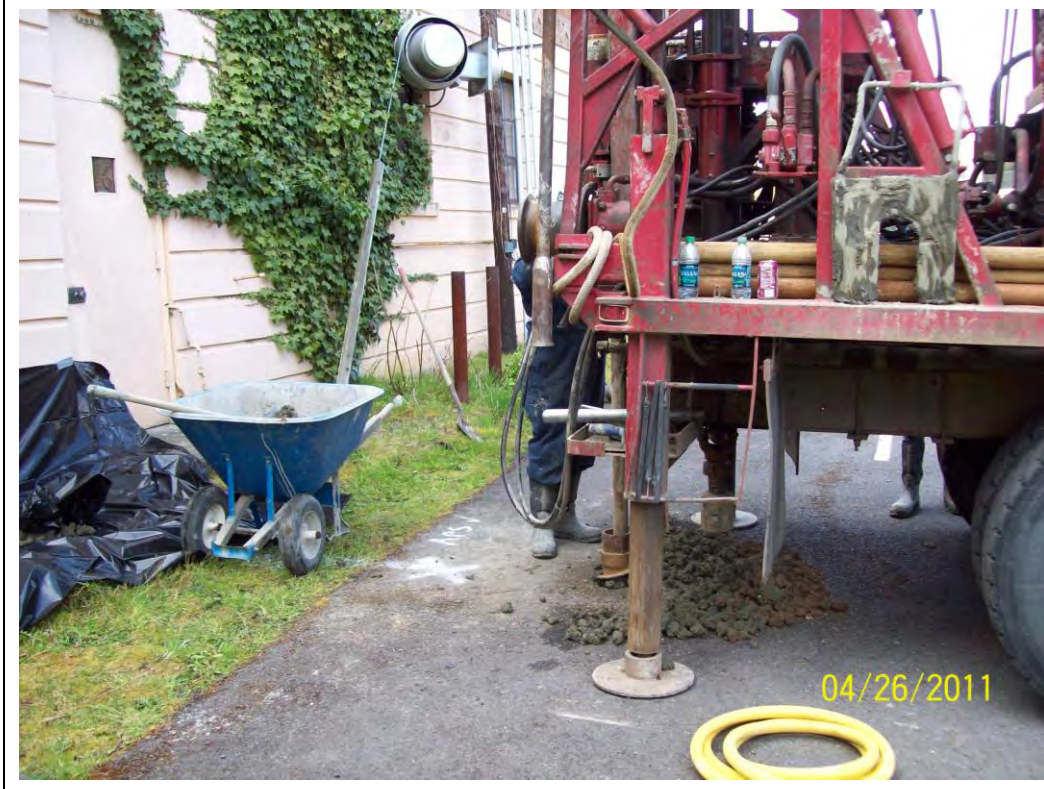
8. Soil profiles were very similar in both of the boreholes, with very soft and soft clays encountered to depths of approximately 30 to 35 feet. Note bedding clay cuttings.

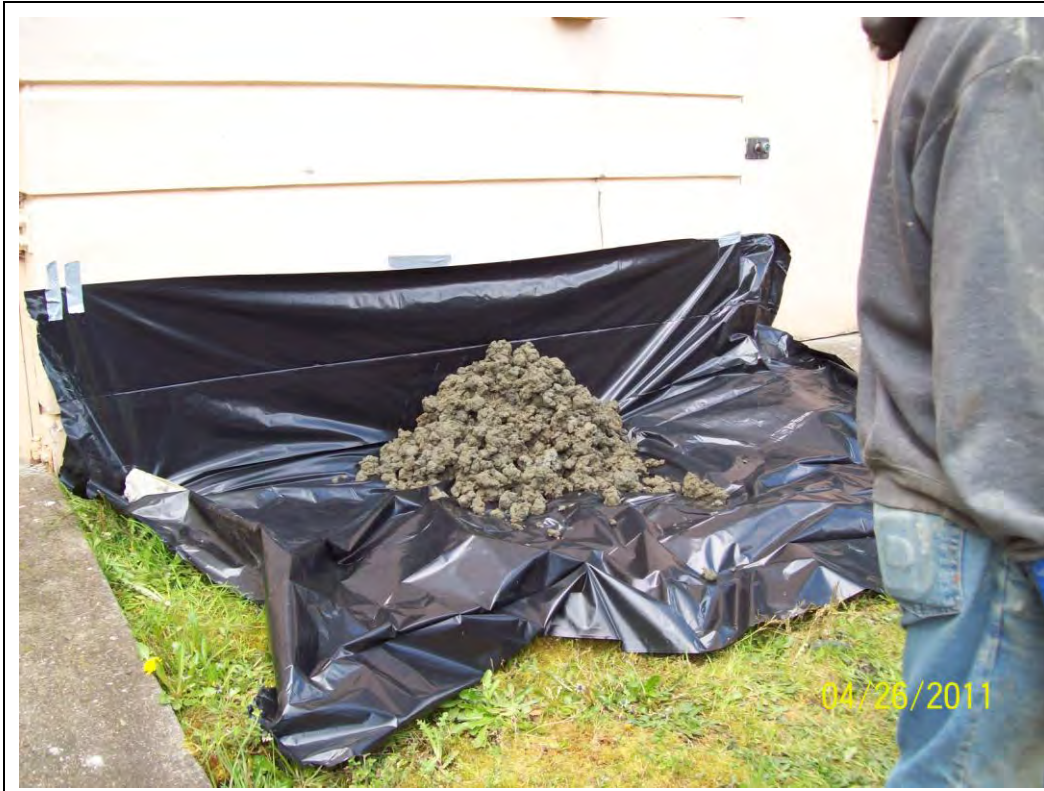
7. Contamination was also encountered in borehole B2, at depths of 5-10 feet bgs, and at about 33 feet bgs. Cuttings were isolated on plastic, wrapped, and left at the site for future disposition.

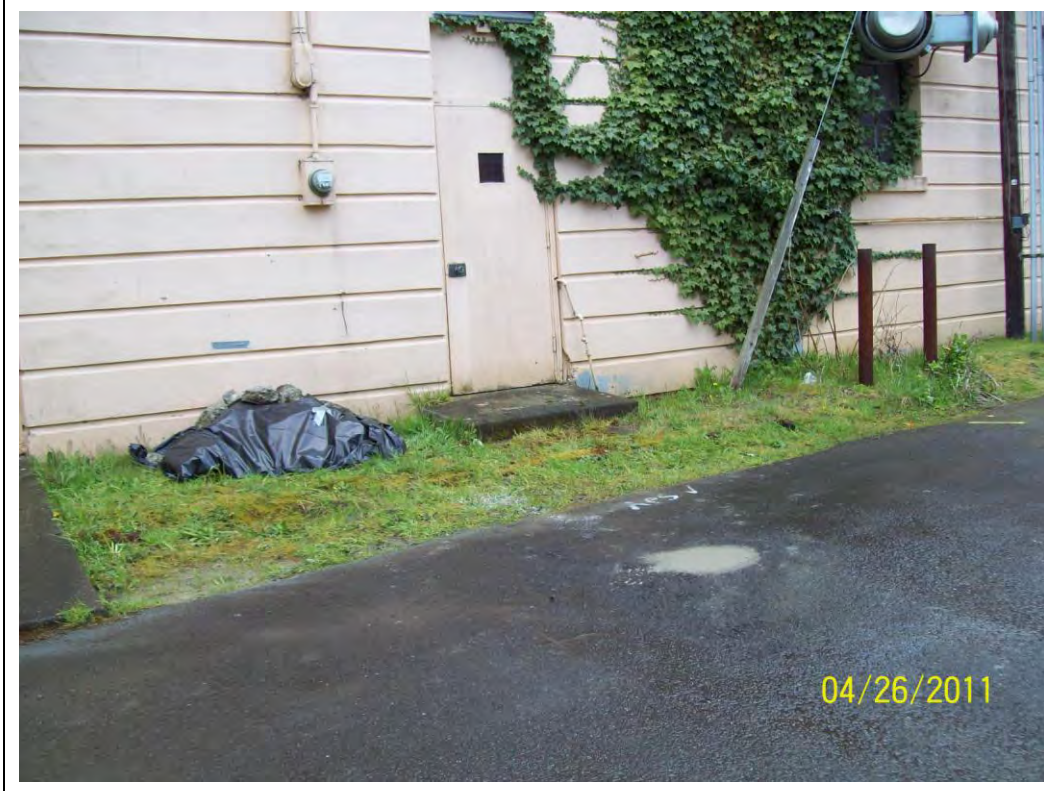
8. The drilling areas were cleaned up following concrete capping of boreholes. It is noted that the origin of contamination was not known. A magnetometer suggested a UST, but could not definitively locate one near the borehole.
