PORT ANGELES FIRE HOUSE

Condition Assessment

July 2011

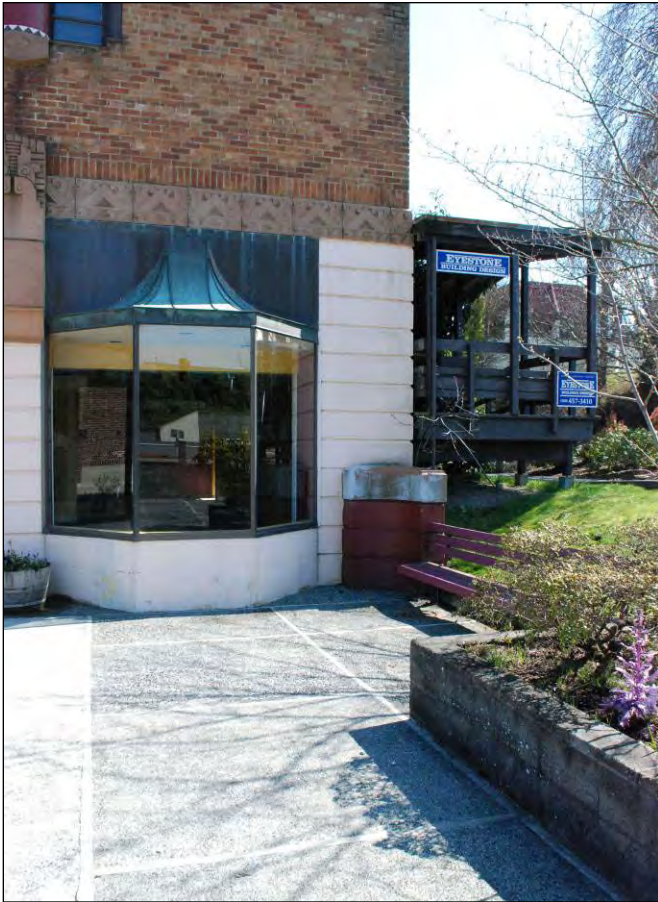
Figure 8 Left: Detail view of bay window, west façade, and freestanding wood access ramp (April 2011)

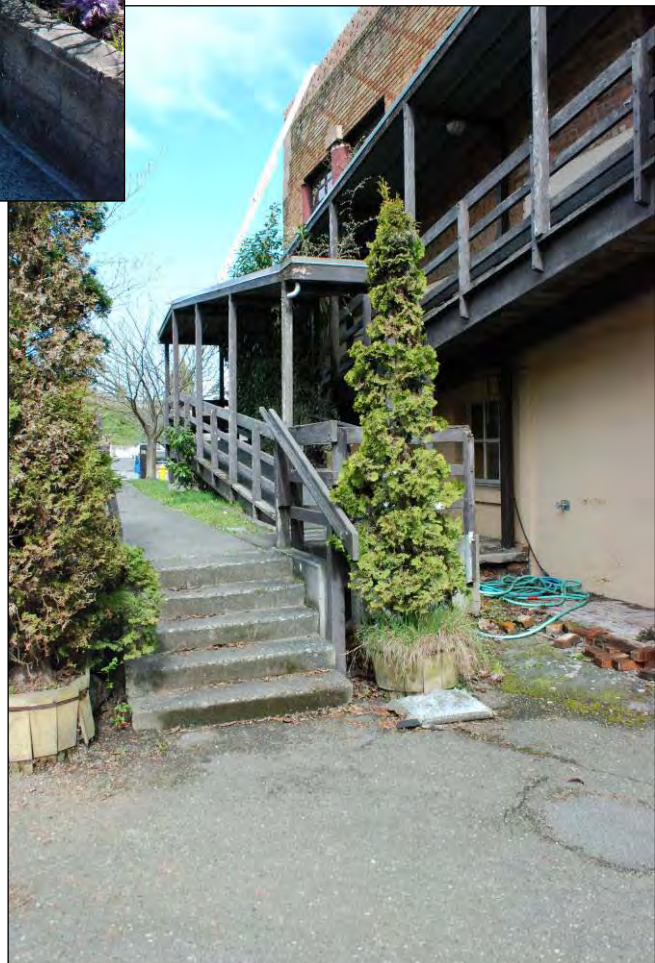
Figure 9 Below: View of freestanding wood access ramp, on the south side of the building looking north (April 2011)

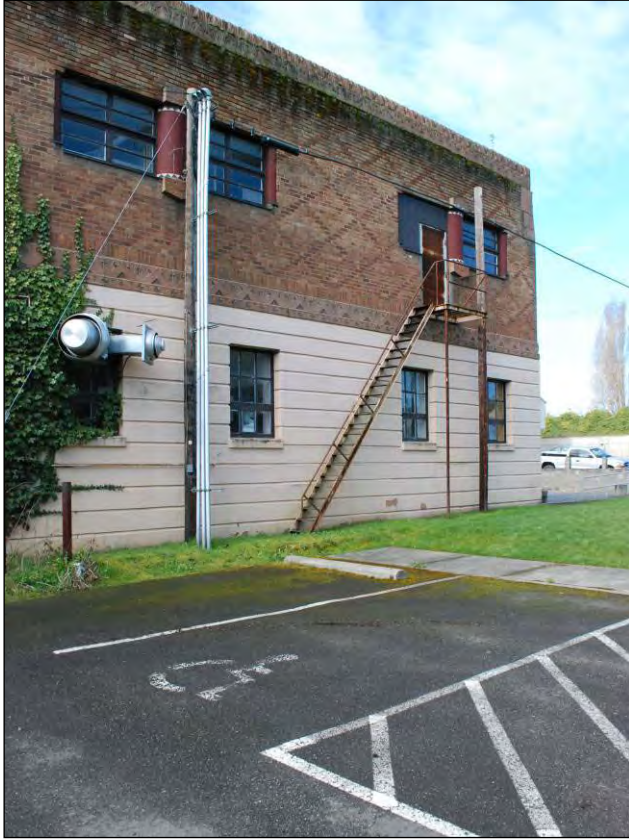
Figure 10 Left: Detail view of fire escape, looking across the parking lot north of the building towards the west (April 2011)

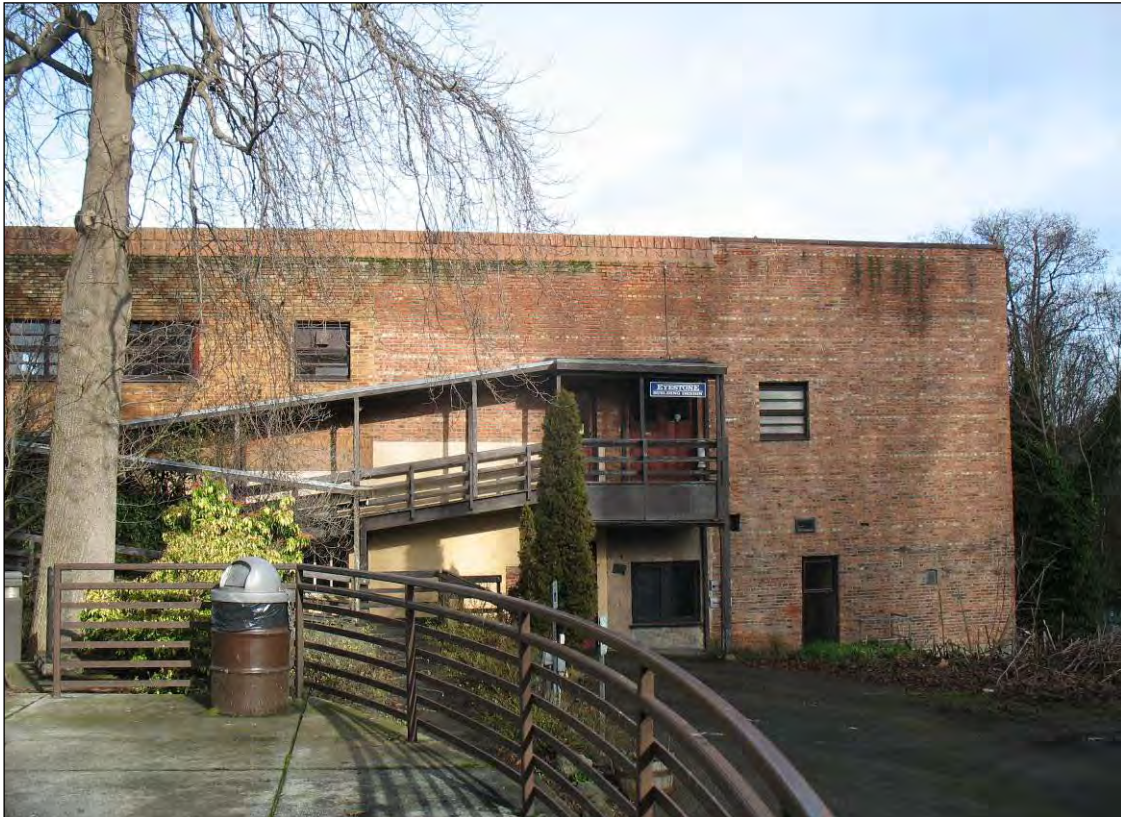
Figure 11 Below: View of south side of building and freestanding access ramp from Veterans Park (April 2011)

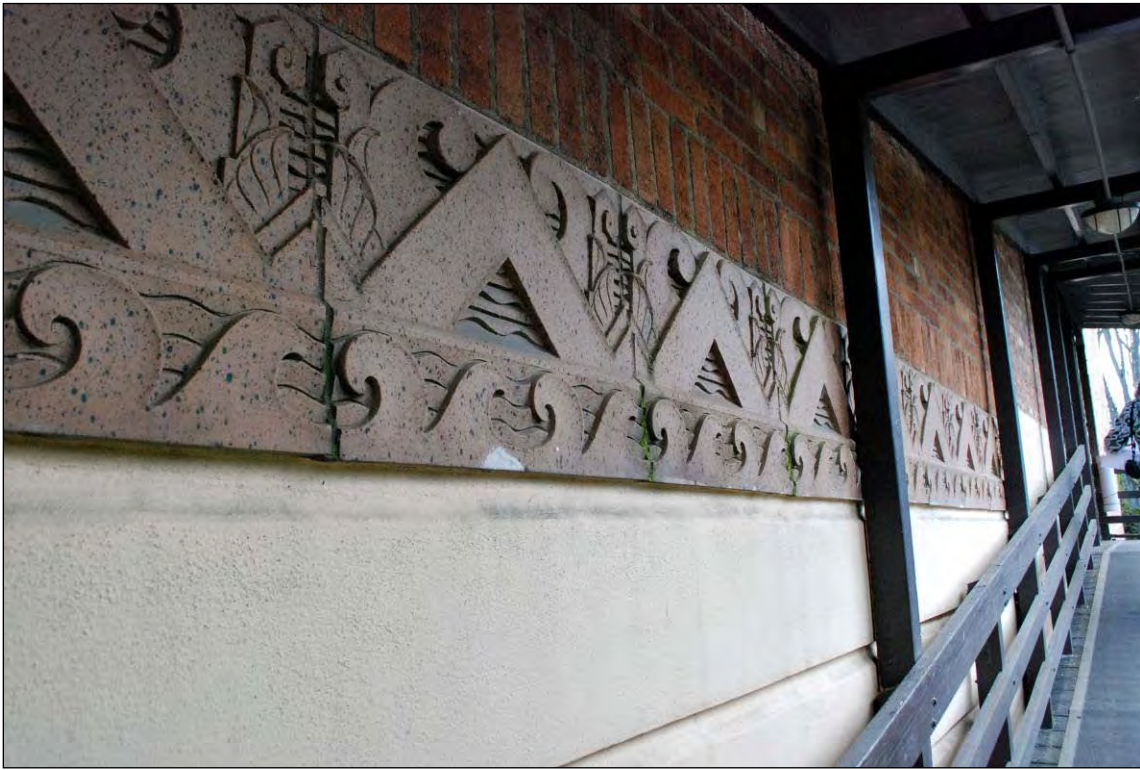
Figure 12 Above: Detail view of decorative terra cotta banding (April 2011)

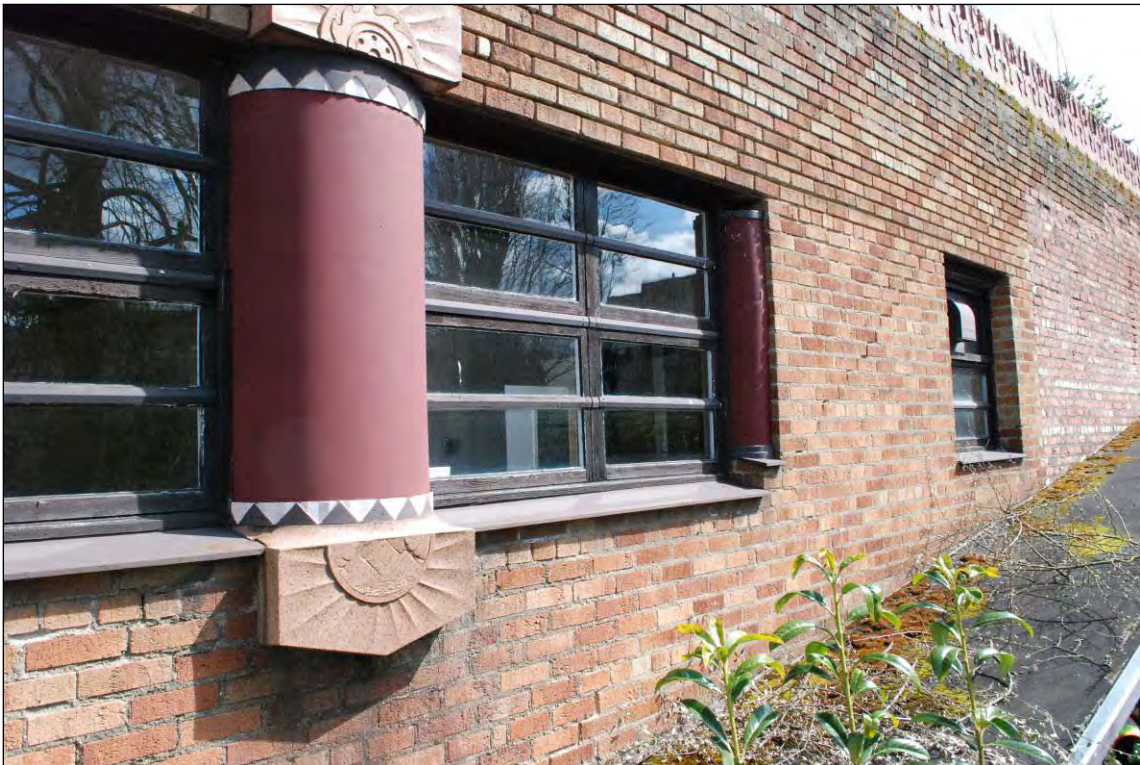
Figure 13 Below: Detail view of second level wood windows, with painted metal columns and decorative terra cotta pieces (April 2011)

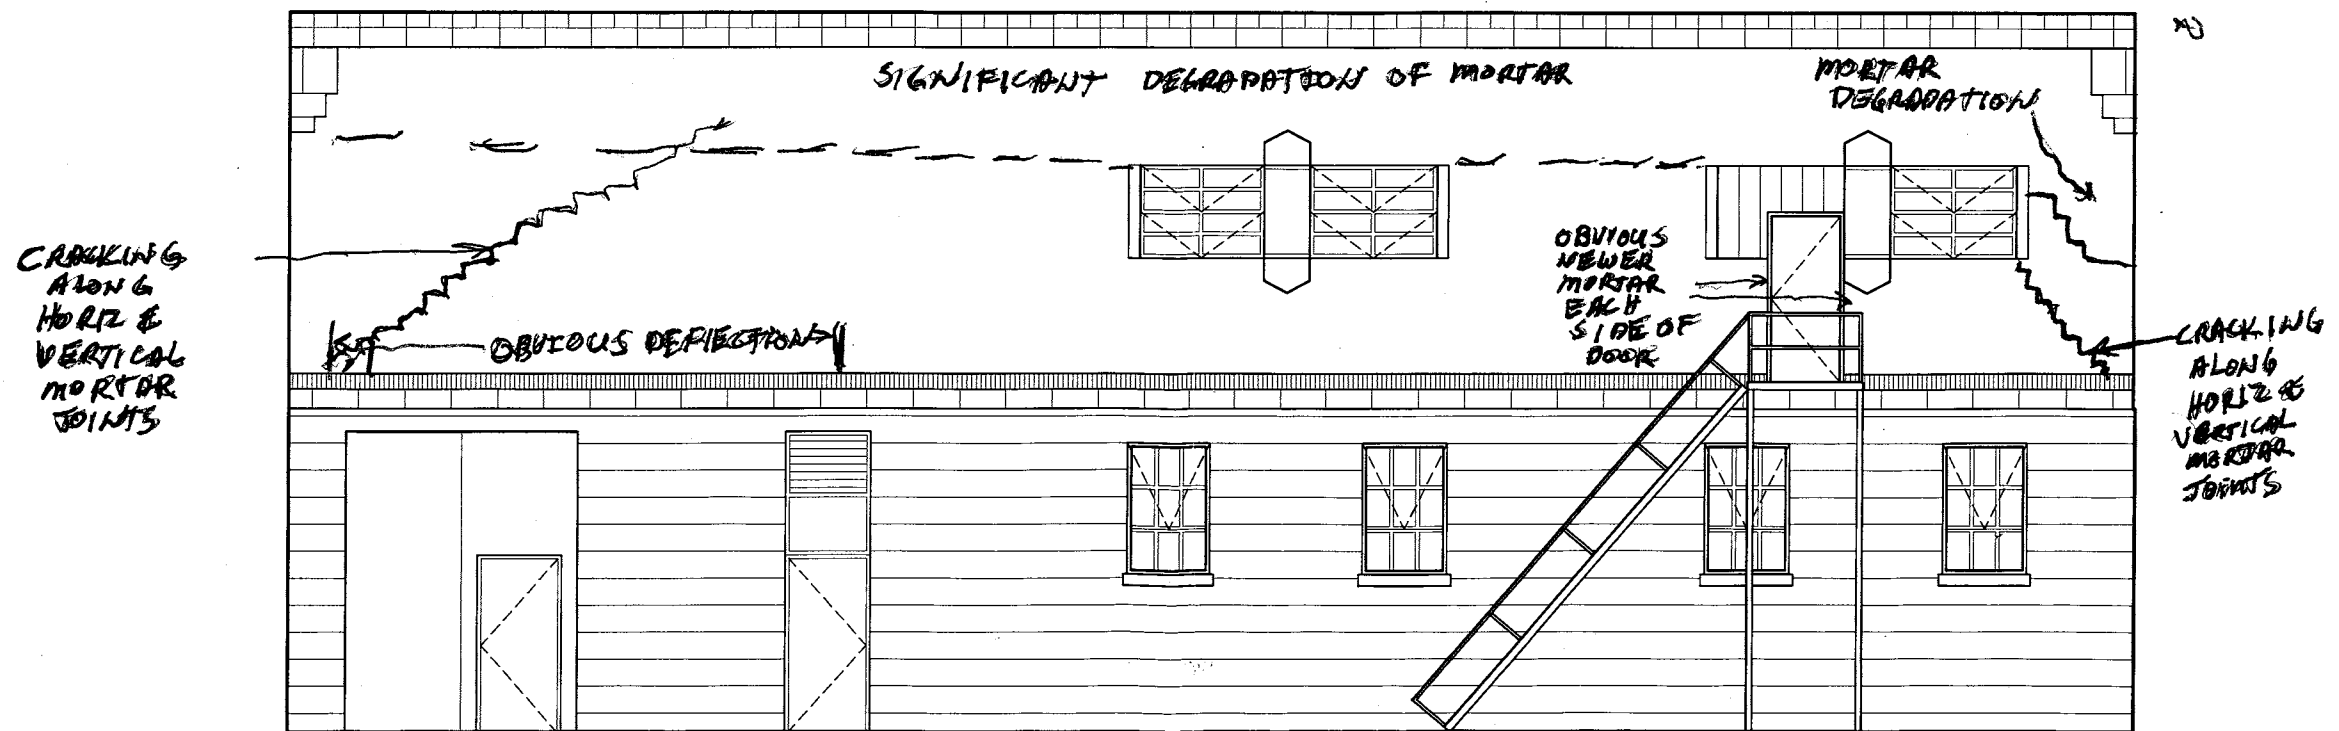
West and North Elevations 1/8" = 1'-0"
April 12, 2011

WEST NORTH ELEVATION: MORTAR HAS DEGRADED SERIOUSLY AT TOP 4' OF WALL AND AT MORTAR JOINTS AT EACH END OF WALL, MAINLY AT LEVEL LINE AT TOP OF WINDOWS

NORTH WEST ELEVATION: SAME DEGRADED MORTAR AT LINE ABOVE WINDOWS AND AT NORTH END OF WALL. MORTAR CRACKING AT ALONG MORTAR JOINTS TOOK PLACE AT EACH END OF WALL WITH MORE SERIOUS CRACKING AT ~~WEST~~ EAST END. AT ~~SOUTH~~ EAST END OF WEST ELEVATION IT APPEARS TO HAVE DEFLECTION AT TERRA COTTA MATERIAL ON TOP OF CONCRETE WALL.

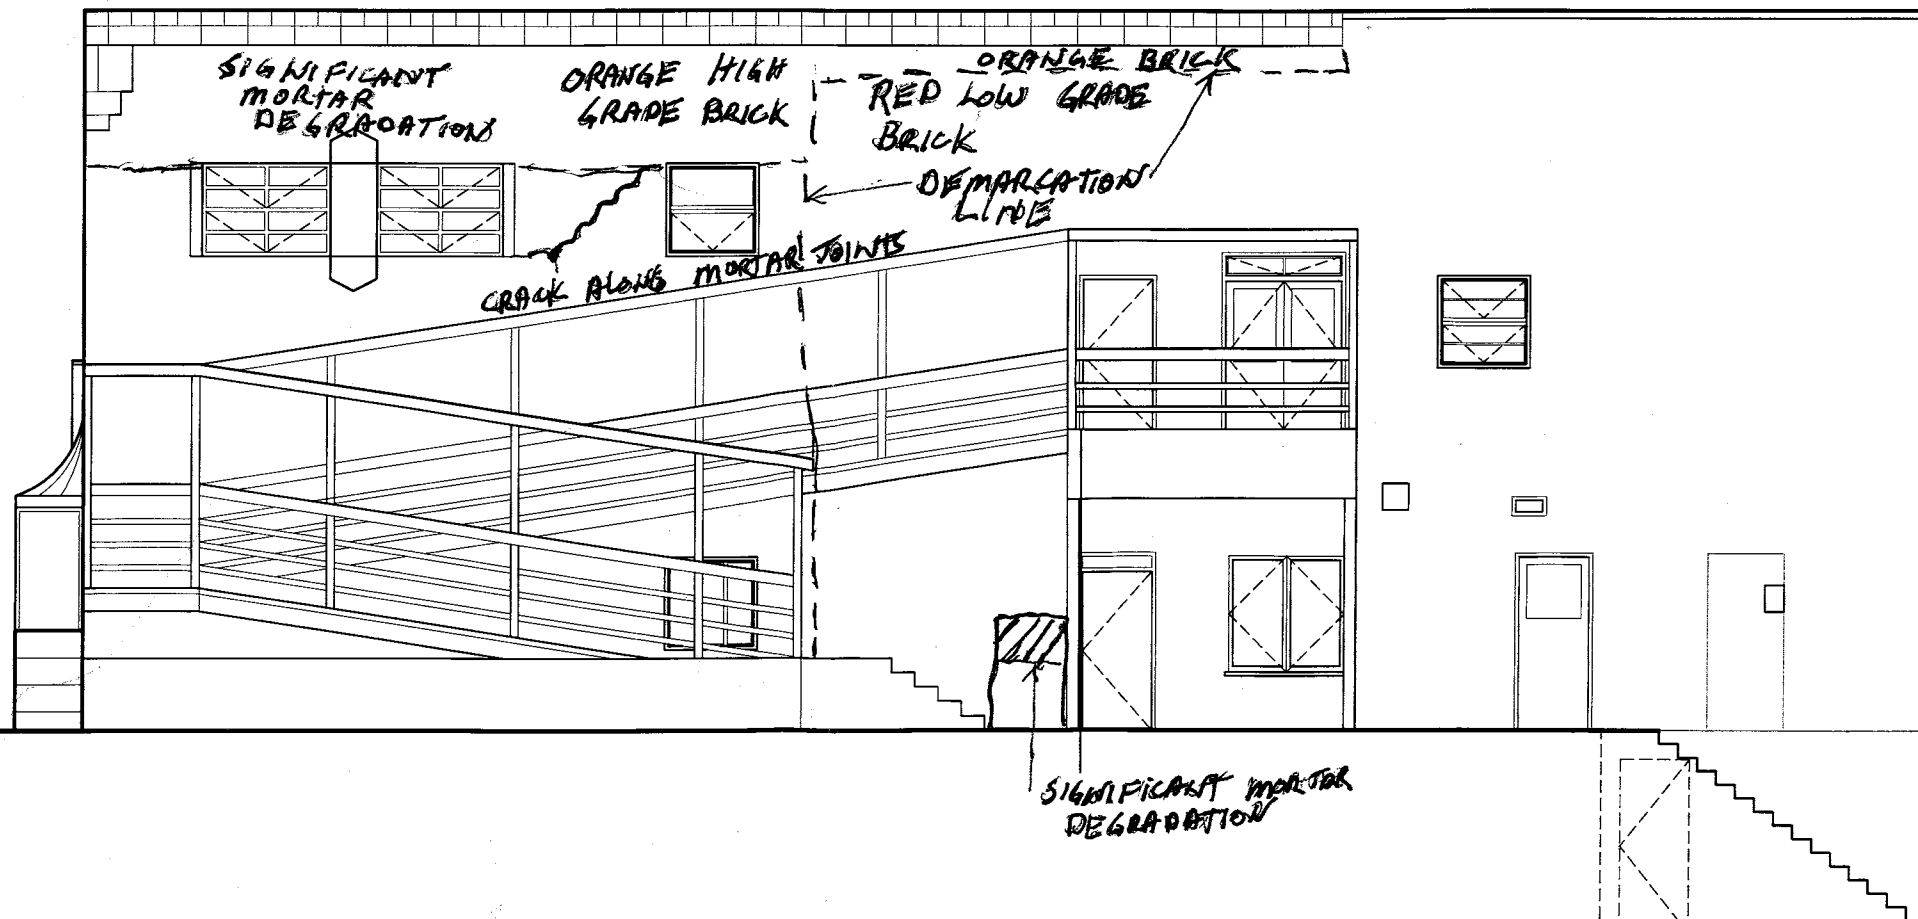
East and South Elevations 1/8" = 1' - 0"
April 12, 2011

~~EAST~~ SOUTH ELEVATION CON'T: UPON CRUMBLING RED BRICK MORTAR BETWEEN MY FINGERS IT APPEARS TO HAVE LIME CONTENT. BETWEEN UPPER WINDOW'S CRACKS AT MORTAR JOINTS SIMILAR TO EAST ELEVATION.

GENERAL: WHAT APPEARS TO BE ORIGINAL MORTAR OF THE BUILDING CAN BE EASILY FLAKED OFF BY RUBBING WITH FINGERS. GRAY AREAS OF MORTAR ARE WHITENED BY REMOVAL OF OUTER LAYER. OTHER THAN TOP 4' MORTAR GENERALLY SEEMS TO BE IN GOOD CONDITION. ORIGINAL BRICK CONSTRUCTION HAD HIGH LEVELS OF WORKMANSHIP AND ATTENTION TO QUALITY, EXCEPT FOR AREA OF RED BRICK, EAST SOUTH WALL IT DOES NOT APPEAR TO HAVE NEWER MORTAR REPLACED TO ANY EXTENT.
