**CITY OF PORT ANGELES
GRANT No. G1000051**

**SHORELINE INVENTORY, CHARACTERIZATION AND ANALYSIS REPORT
for City of Port Angeles' Shoreline: Strait of Juan de Fuca
June 2012**

June 2012

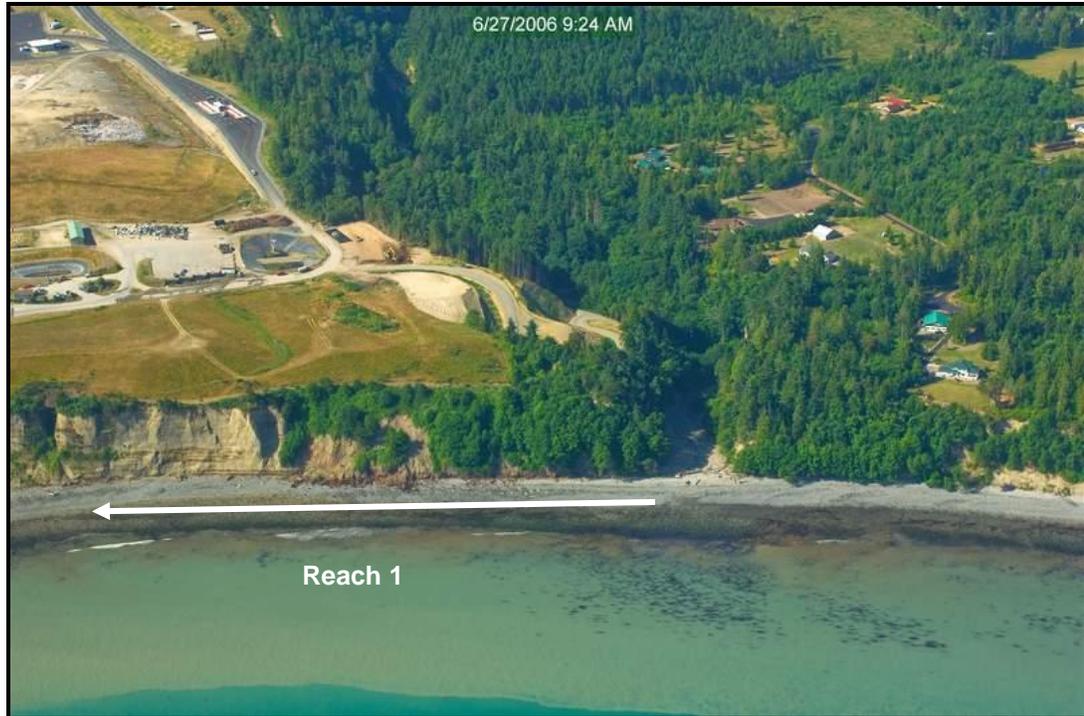
Exhibit 2. Reach 1 facing south, prior to seawall construction (Ecology Coastal Atlas, June 2006).

Reach 1 is located at the western edge of the City limits, bounded on the west by Dry Creek (Exhibit 2). As the name implies, this reach is dominated by a closed landfill (now transfer Station), with the portion adjacent to the shoreline a no longer active, and unlined cell. This is a high-bluff shoreline, most of which is nearly vertical, but with the western portion, nearest to Dry Creek, with a more stable slope near the angle of repose. Dry Creek is relatively steep with little fan development and little estuary habitat. According to WDFW, it is used by four priority fish species: chum and coho salmon, coast resident cutthroat trout, and steelhead trout. Trees dominate the shoreline near Dry Creek, but are sparse in the remainder of the reach. A seawall was installed at the toe of the bluff in 2007 (Exhibit 3) to prevent continued erosion of landfill material into the Strait. The seawall extends the entire 620 feet of the landfill beach cell and rises 15 feet above the beach. The seawall is located approximately 100 feet east of the mouth of Dry Creek. As a condition of the approval for the seawall is the annual placement of beach materials to replace the sediment that is no longer provided by the marine bluff.

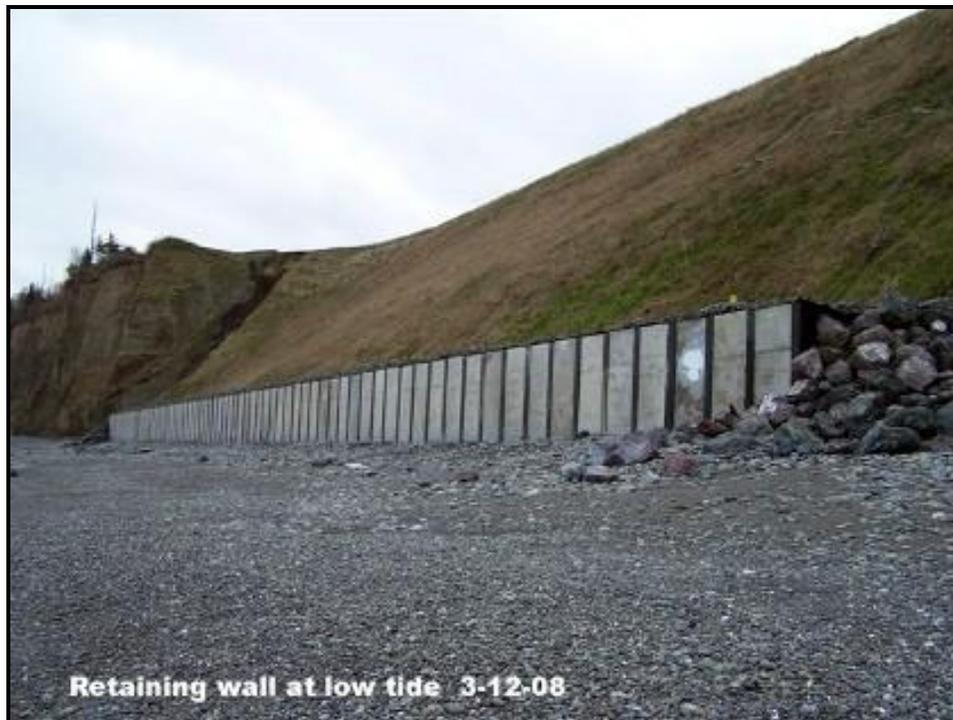
Exhibit 3. Seawall constructed in 2007 at toe of slope (photo taken by Dry Creek Coalition, http://drycreekcommunity.org/index.php/gallery/image_full/262/)

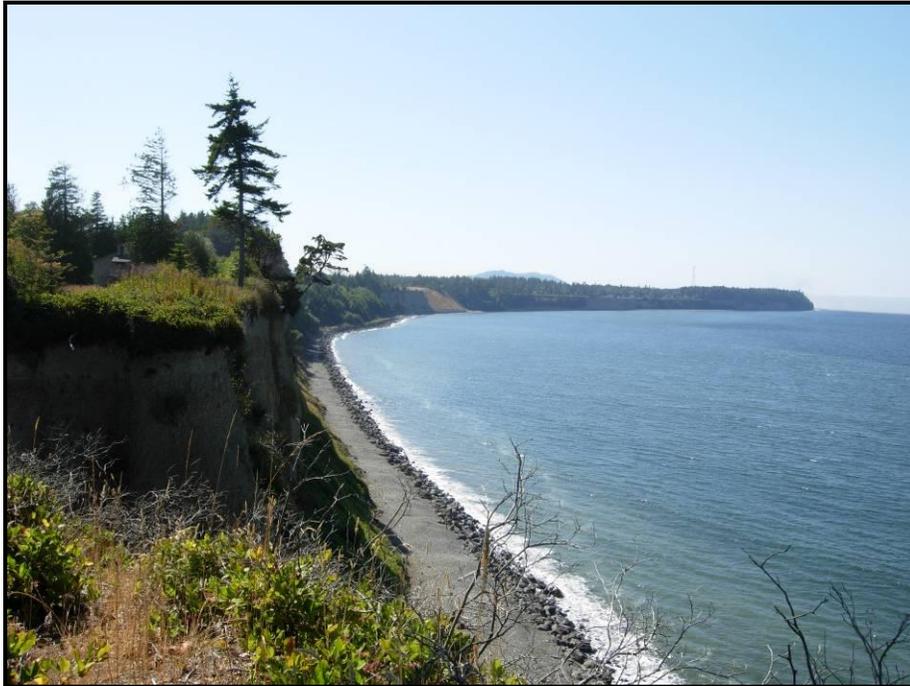
Exhibit 4. Reach 2 photo of bank armoring and pathway (photo taken by Makers, July 2010).

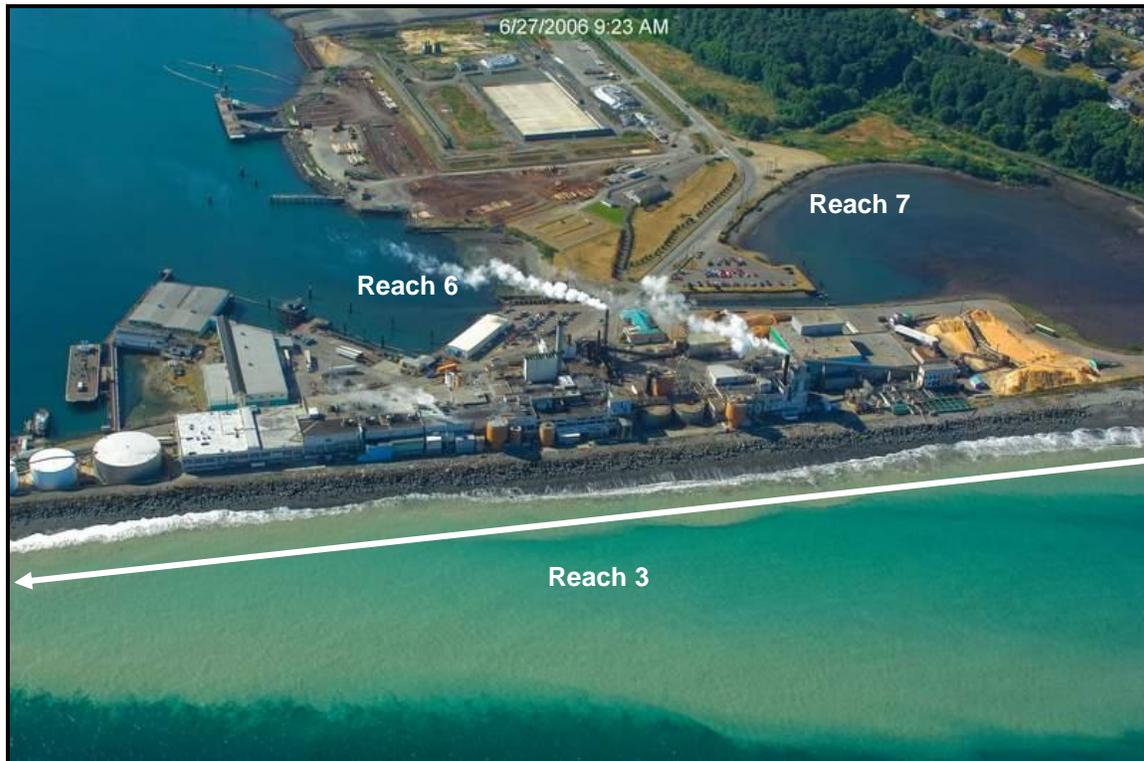
Exhibit 6. Central portion of Reach 3 facing south (Ecology Coastal Atlas, June 2006).

Reach 3 extends three-quarters of a mile along the highly altered, industrial portion of the base of Ediz Hook occupied by Nippon Paper Industries. Virtually the entire reach is armored (Exhibit 6). A small area approximately 650 feet in length remains unarmored and forms a pocket beach. This small beach area is located at the western end of the Nippon Mill site.

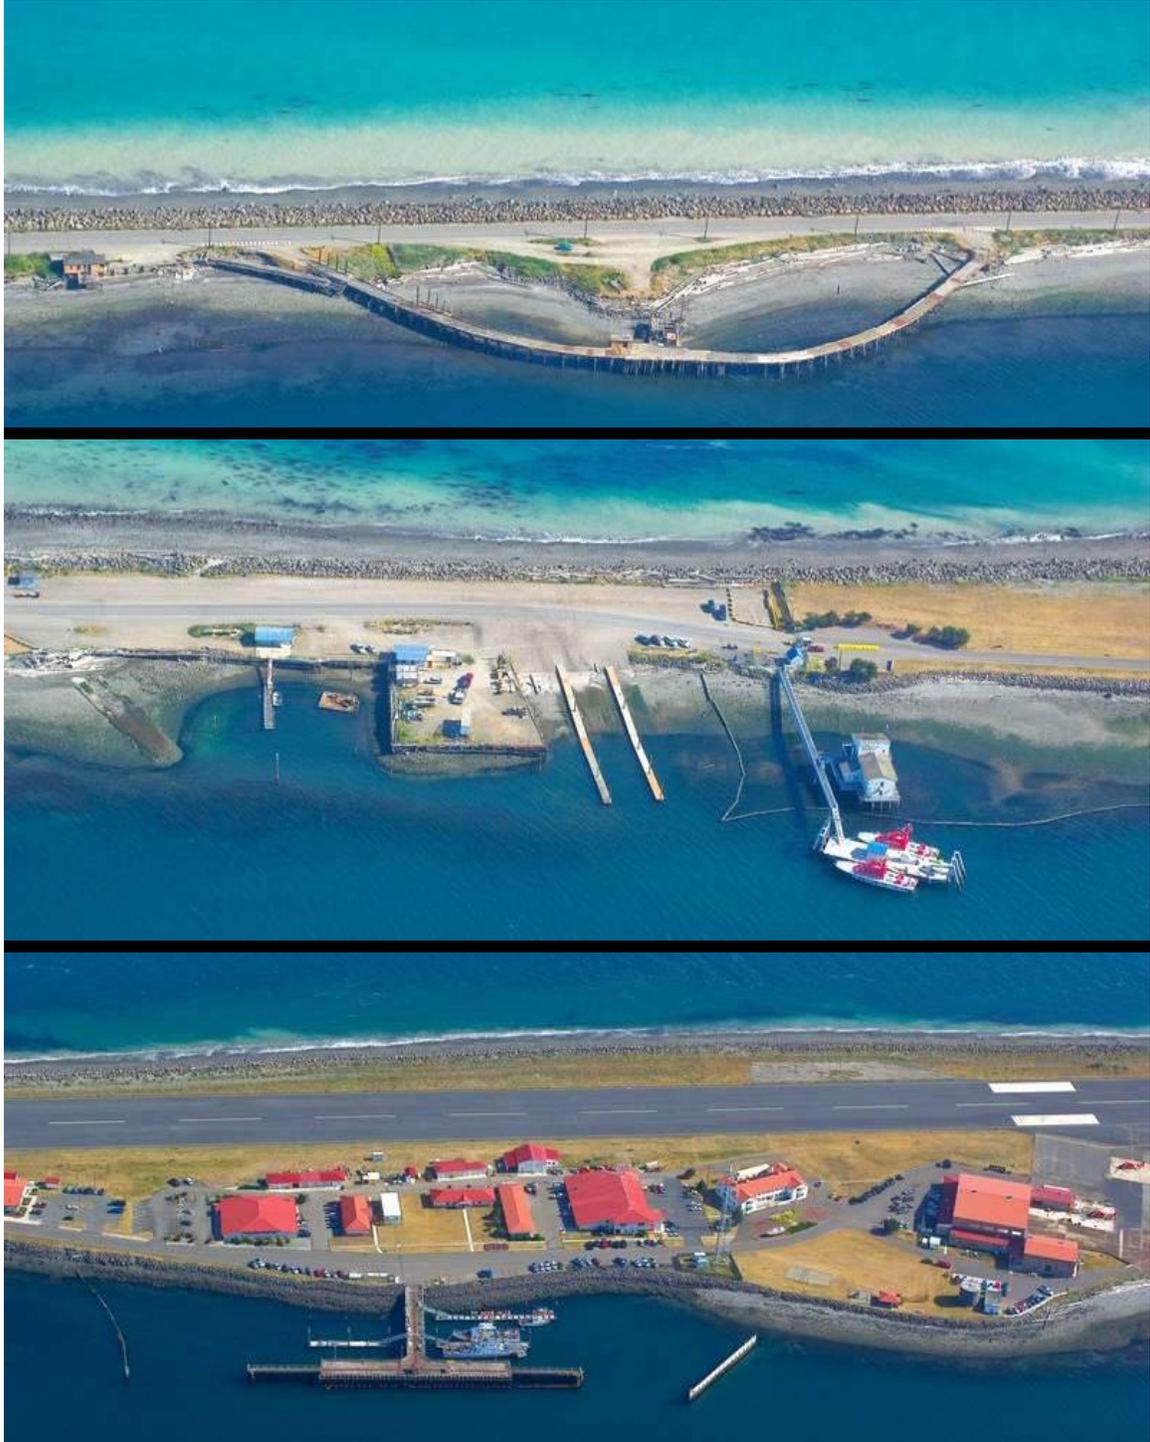
Exhibit 9. Variety of shoreline modifications along Reach 5, all facing north (Ecology Coastal Atlas, June 2006). The structure in the top picture has been removed.

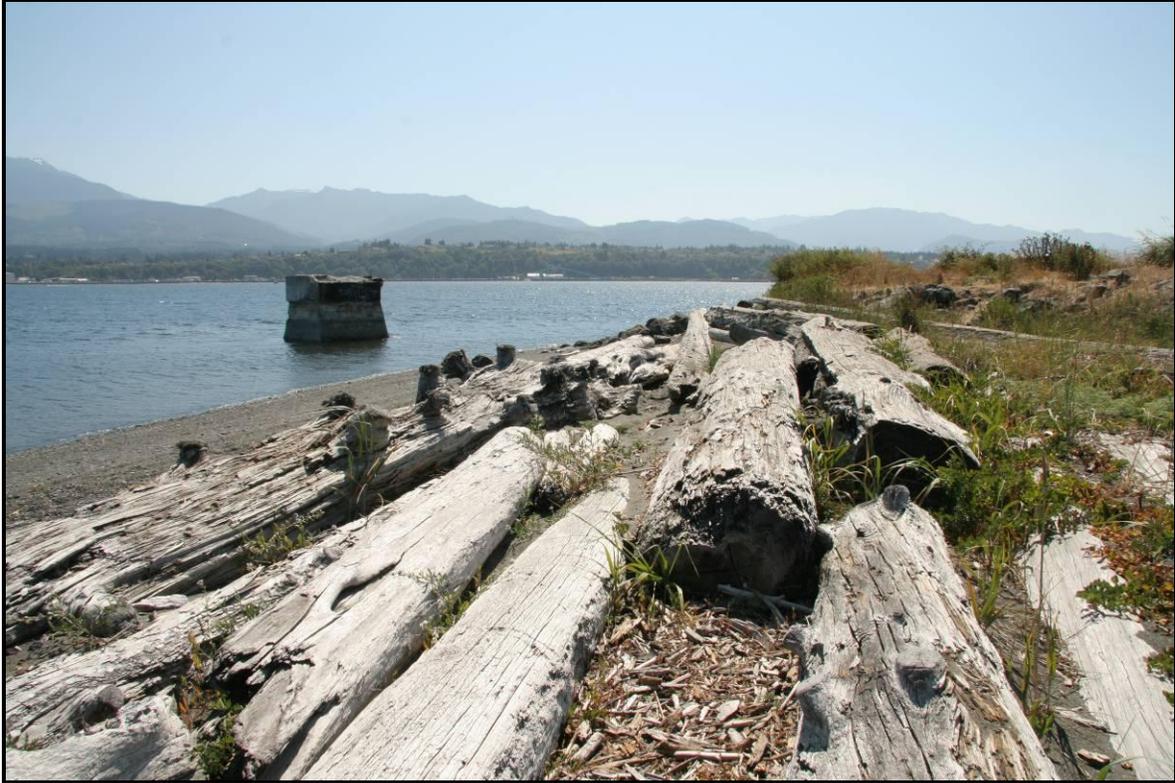
Exhibit 10. Reach 5 photo of unarmored beach and collected large woody debris at the location of the now removed "A-Frame" structure shown in the top photo of Exhibit 9. (photo taken by Makers, July 2010).

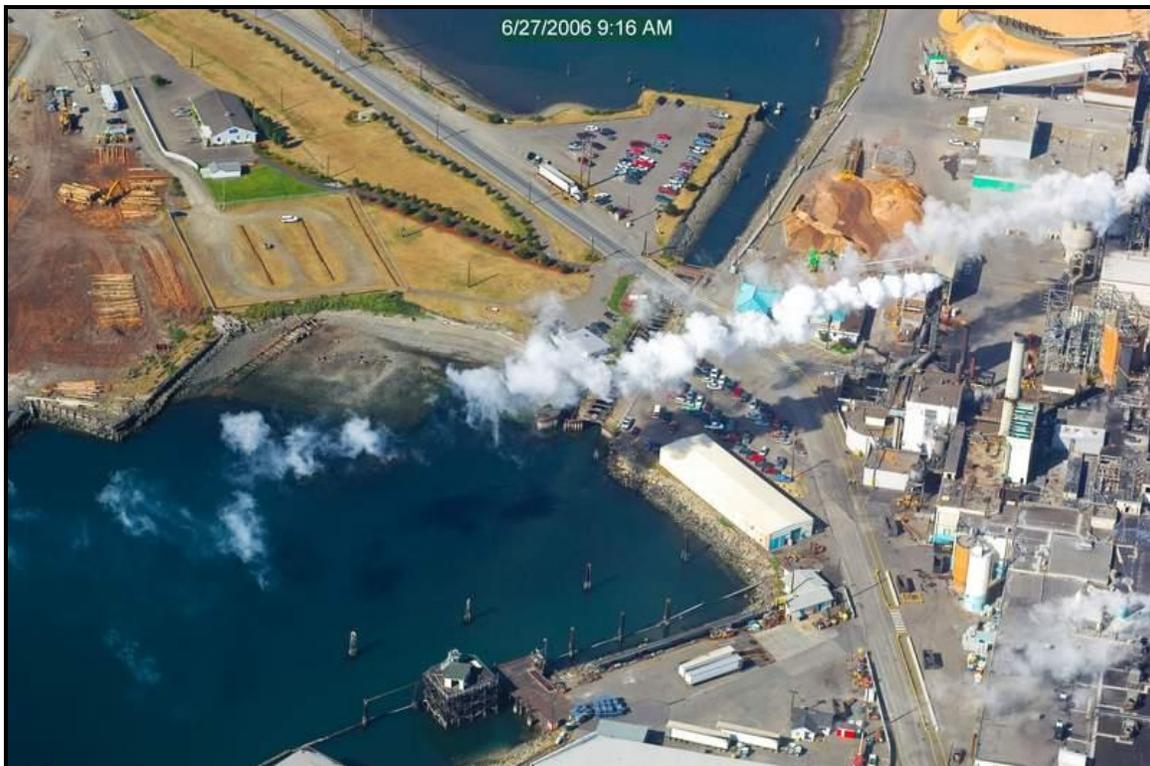
Exhibit 11. View of Reach 6, facing south-west (Ecology Coastal Atlas, June 2006).

This reach contains the opening to the lagoon area at the base of the hook. This channel, also known as the "Drive Ditch" is armored by sheet pile walls on both sides. A small jetty is located to the south of the channel opening to the harbor, further impacting shoreline functions in the reach. A small portion of the shoreline, approximately 300 feet in length and just south of the lagoon channel is not armored and creates a small pocket beach.

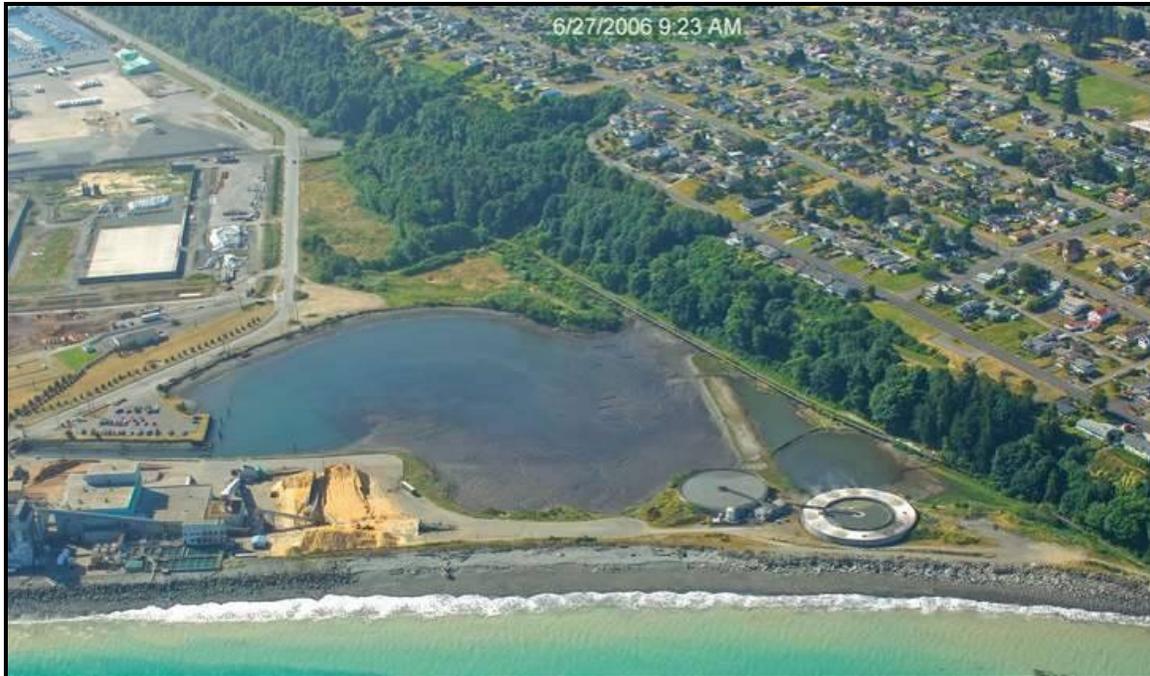
Exhibit 12. View of Reach 7, facing south (Ecology Coastal Atlas, June 2006).

Reach 7 is the old Nippon log storage pond (Exhibit 12), that is no longer used for that purpose. The pond was once a natural lagoon (Ecology and Environment 2008). It is connected to Port Angeles Harbor by a narrow, sheet pile lined canal (Exhibit 13). As characterized by Pentec (2001), the pond is shallow with large areas of mud flat utilized by crabs and clams. A bald eagle historically nests in the forested area to the south. The pond is associated with forested wetlands to the southeast.

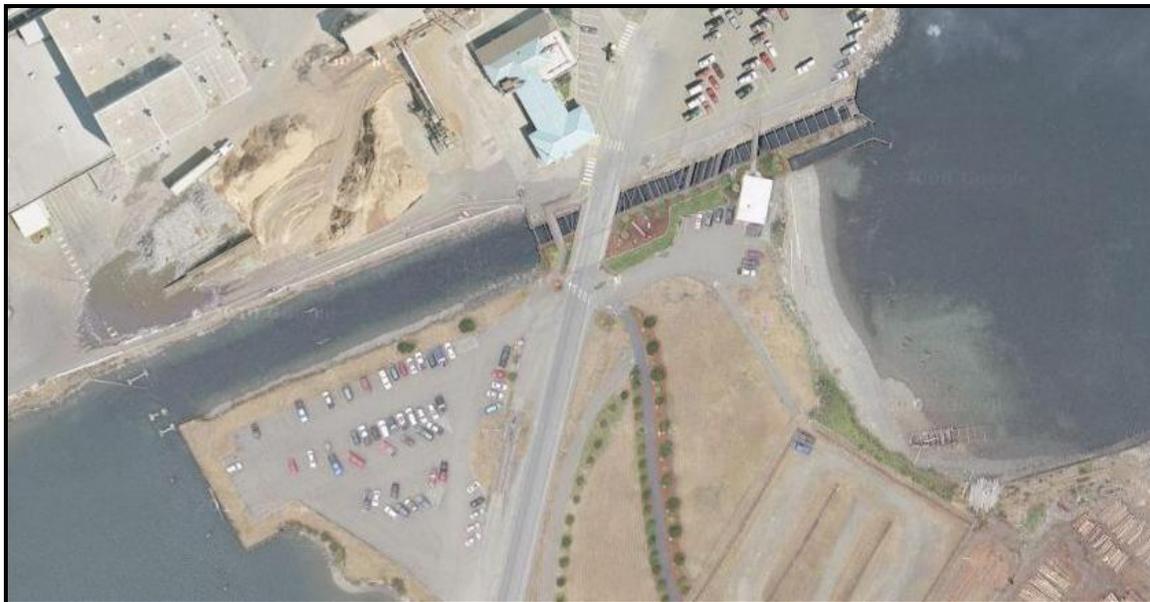
Exhibit 13. Aerial photograph of the channel outlet of the Nippon mill pond to Port Angeles Harbor (Google maps).

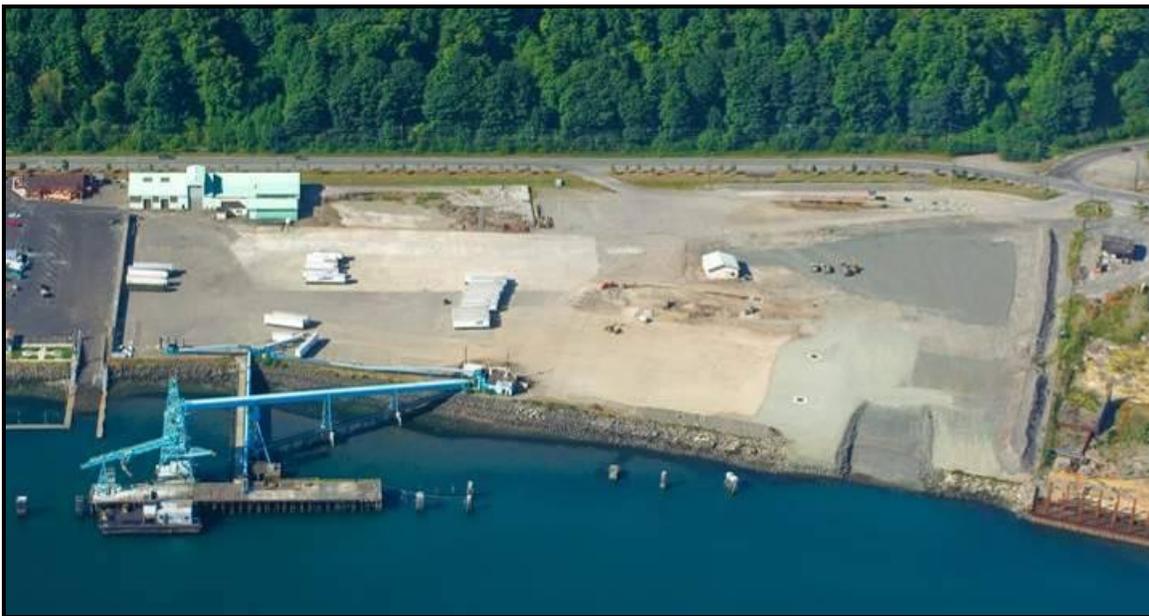
Exhibit 15. View of the southern portion of Reach 8A, facing west (Ecology Coastal Atlas, June 2006). The Port of Port Angeles currently uses this area for log handling operations.

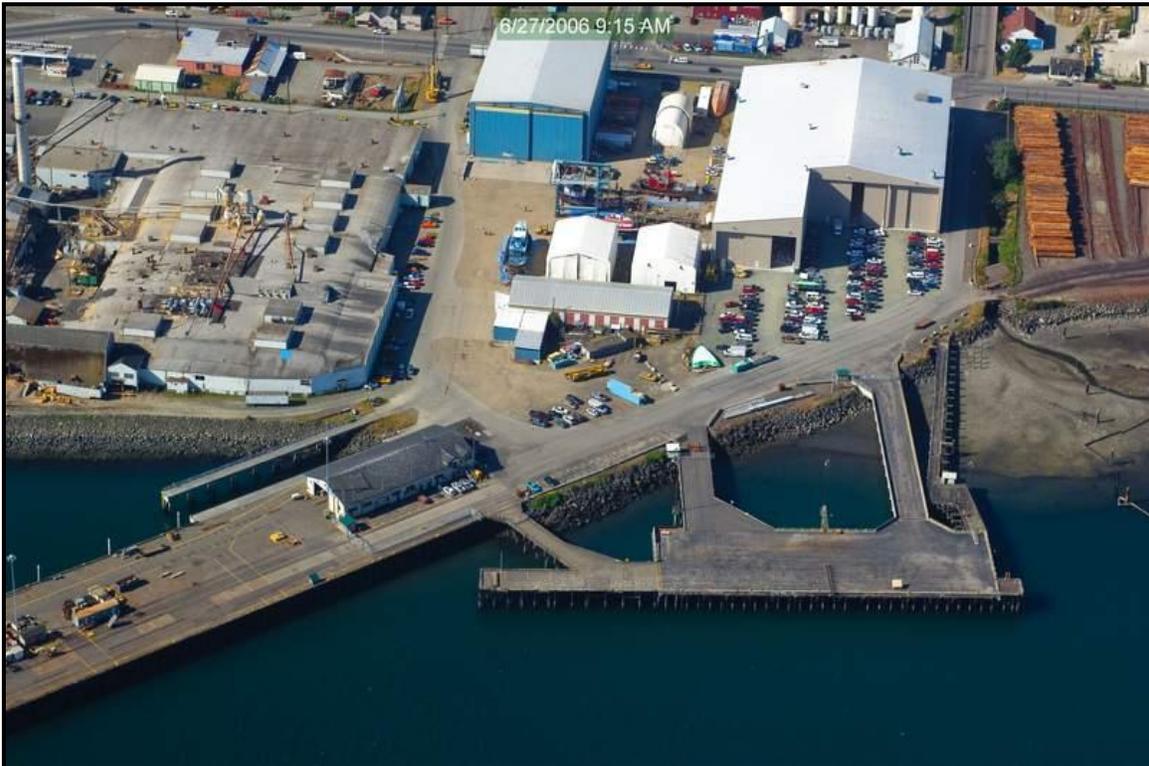
Exhibit 17. View of Reach 8C, facing south (Ecology Coastal Atlas, June 2006).
Note the delta of Tumwater Creek on the right side of the photo. Terminal 3 is shown on the lower right and Terminal 1 on the left.

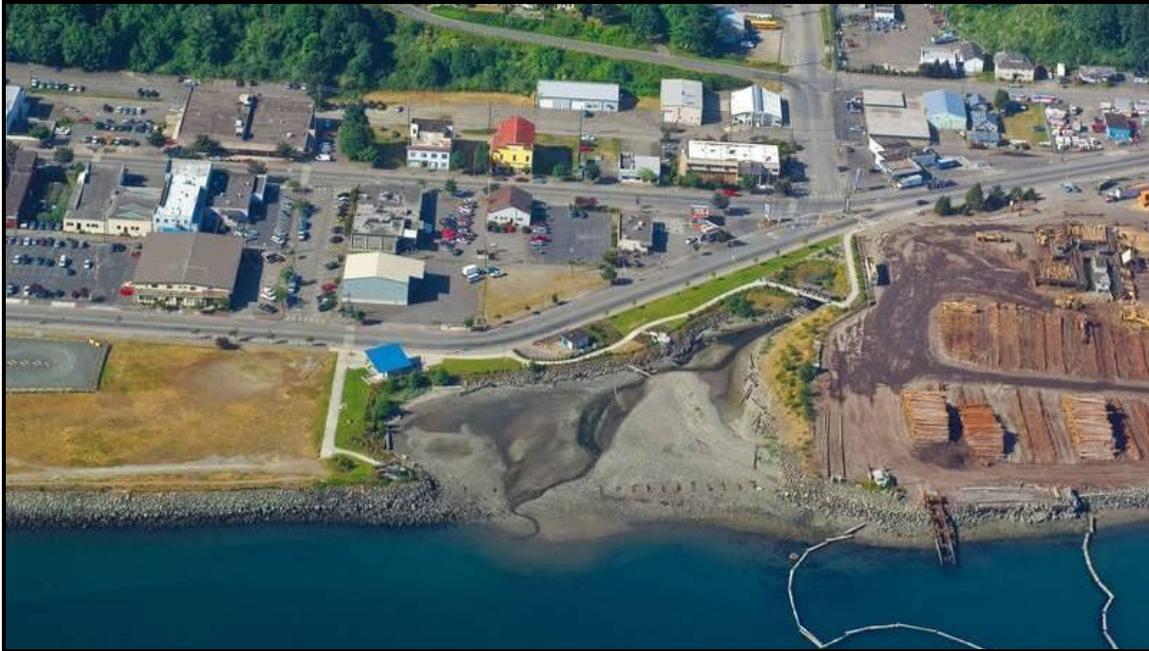
Exhibit 18. View of western portion of Reach 8D, facing south (Ecology Coastal Atlas, June 2006). Note the delta of Valley Creek in the center of the photo.

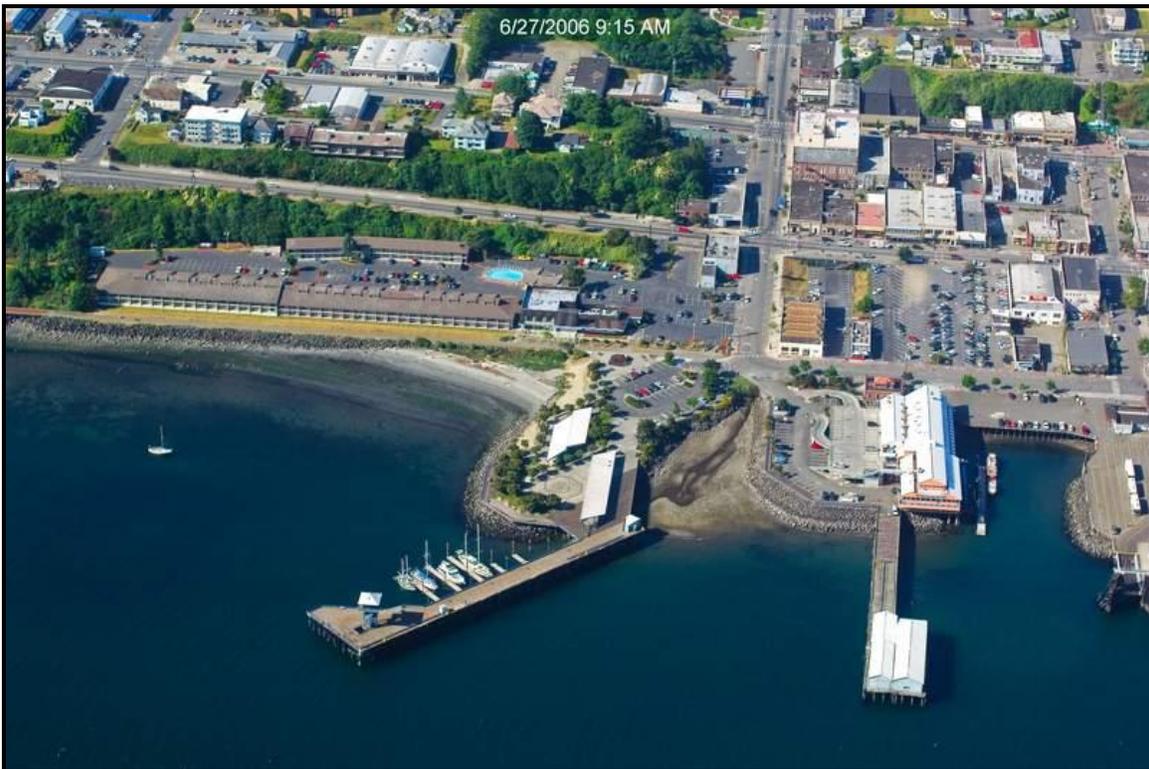
Exhibit 19. View of eastern portion of Reach 8D, facing south (Ecology Coastal Atlas, June 2006). Note the delta of Peabody Creek in the center of the photo.

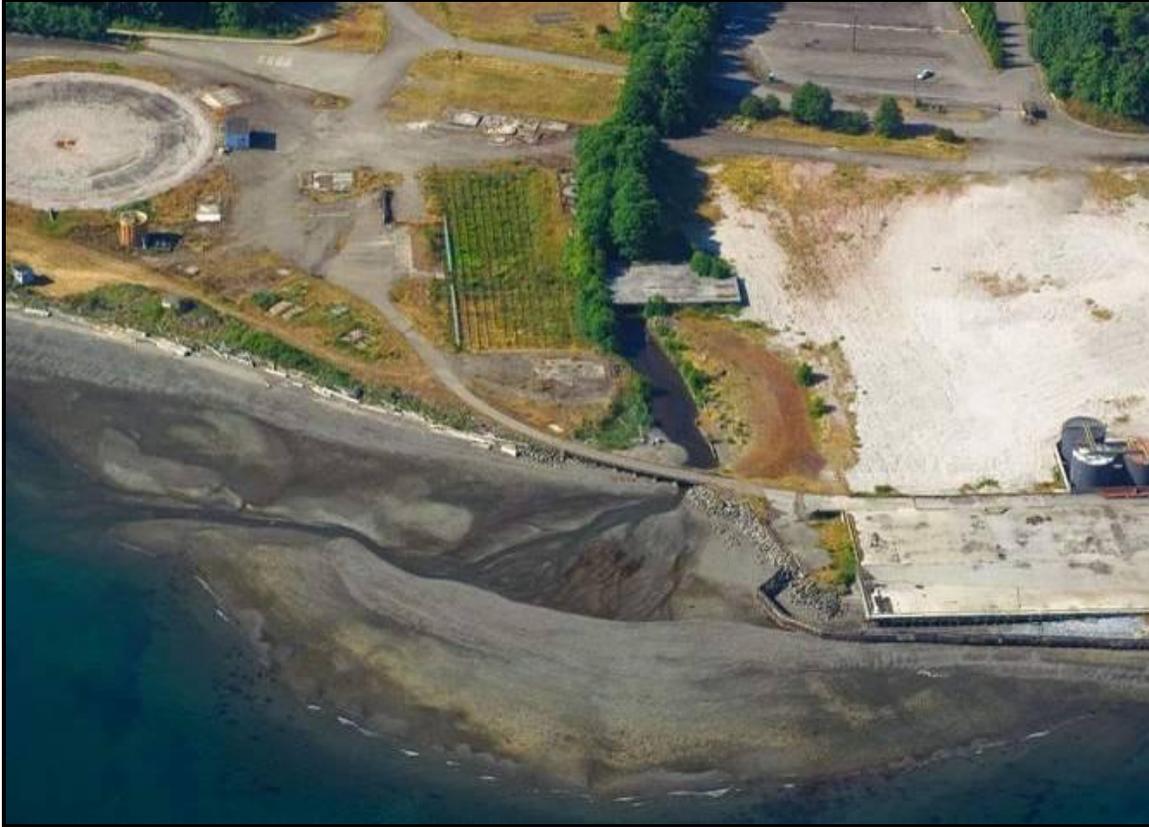
Exhibit 22. View of the central portion of Reach 10, facing south (Ecology Coastal Atlas, June 2006). Note the Ennis Creek delta and stream corridor.

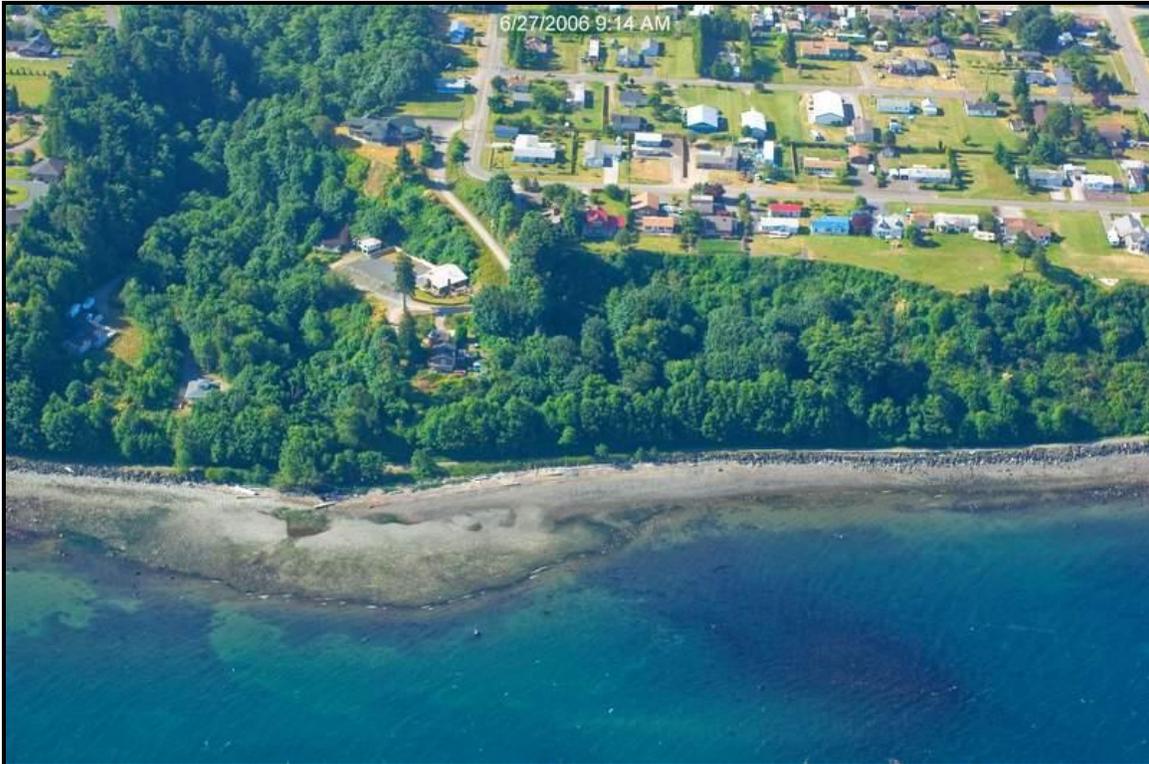
Exhibit 24. View of west-central portion of Reach 11 including the Lees Creek outfall and estuary, facing south (Ecology Coastal Atlas, June 2006).
